Draft Gila River Conceptual Diversion Assessment

Project Reference: NMCAP 30% Design
Project Number: 60504989

January 6, 2017

Prepared For: New Mexico
Interstate Stream Commission

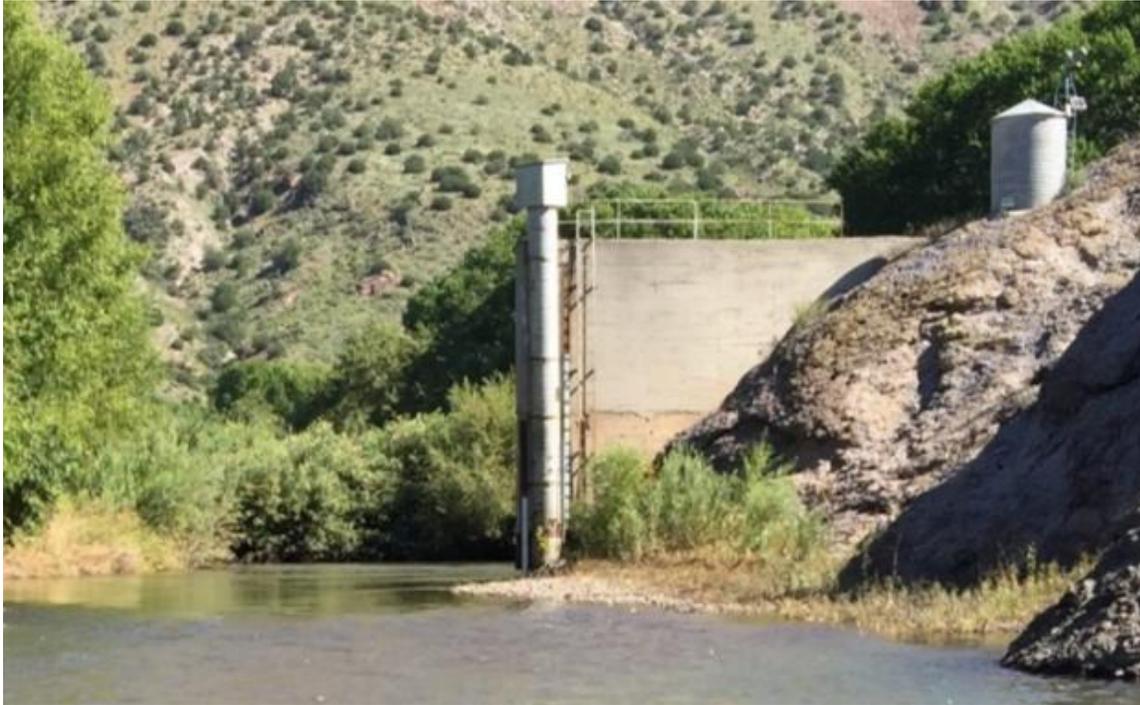
Photo 1 Looking Upstream (North) at the Gila Gage

Observations of the staff gage further corroborate channel degradation in the reach. The staff gage is discontinuous with a secondary staff bolted onto the face of the original stilling well to reach the water surface. A review of the notes related to the establishment and maintenance of the Gila Gage, obtained from the USGS Las Cruces Field Office, also identify that in 1994 the datum was lowered by 1.00 ft and the staff was reset. Channelization work needed to divert the river flow back to the gage was also noted to have occurred in 1971.

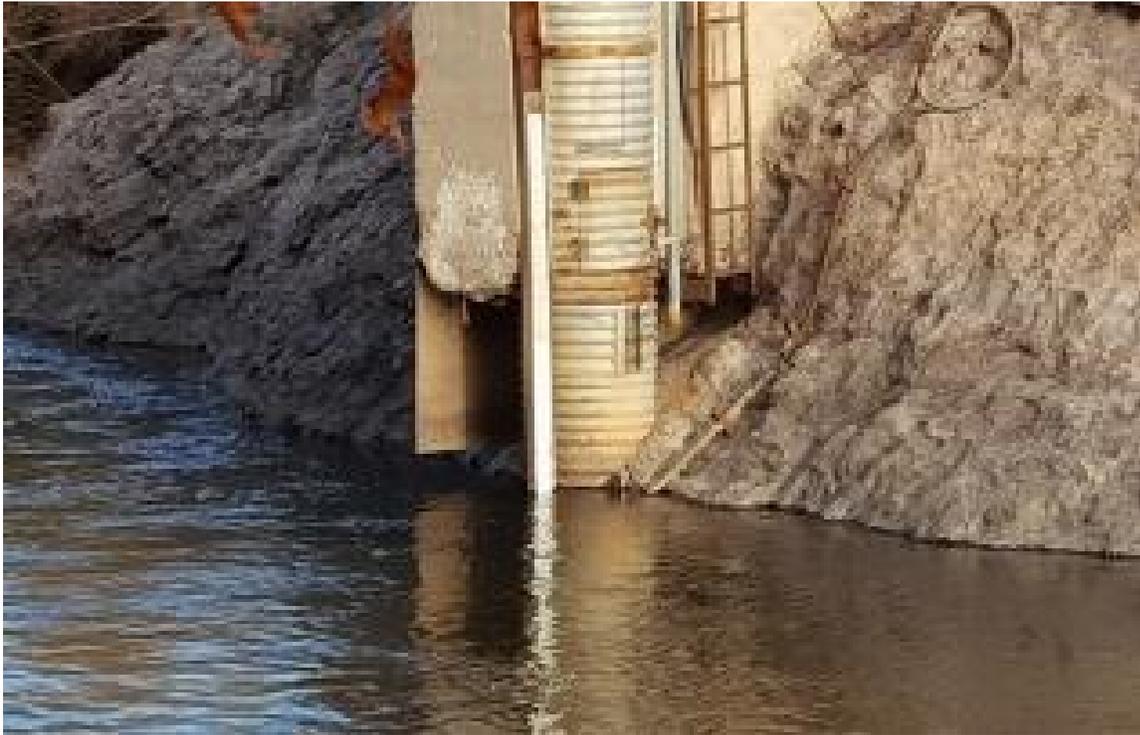
Photo 2 shows a close up of the 18 inch thick concrete wall, stilling well and staff gage. It can be seen that the bottom of the cast in place wall was originally formed by the native alluvium when the river channel was at a higher elevation. As this material washed away through the processes of degradation and channel widening the bottom of the wall was

exposed and now hangs in the air, out over the bedrock shelf. A steel plate has since been bolted onto the face of the concrete wall presumably to protect the stilling well and staff gage from damage during high water events.

Photo 2 Looking Across the Channel (Northeast) at a Close-up of the Gila Gaging Station

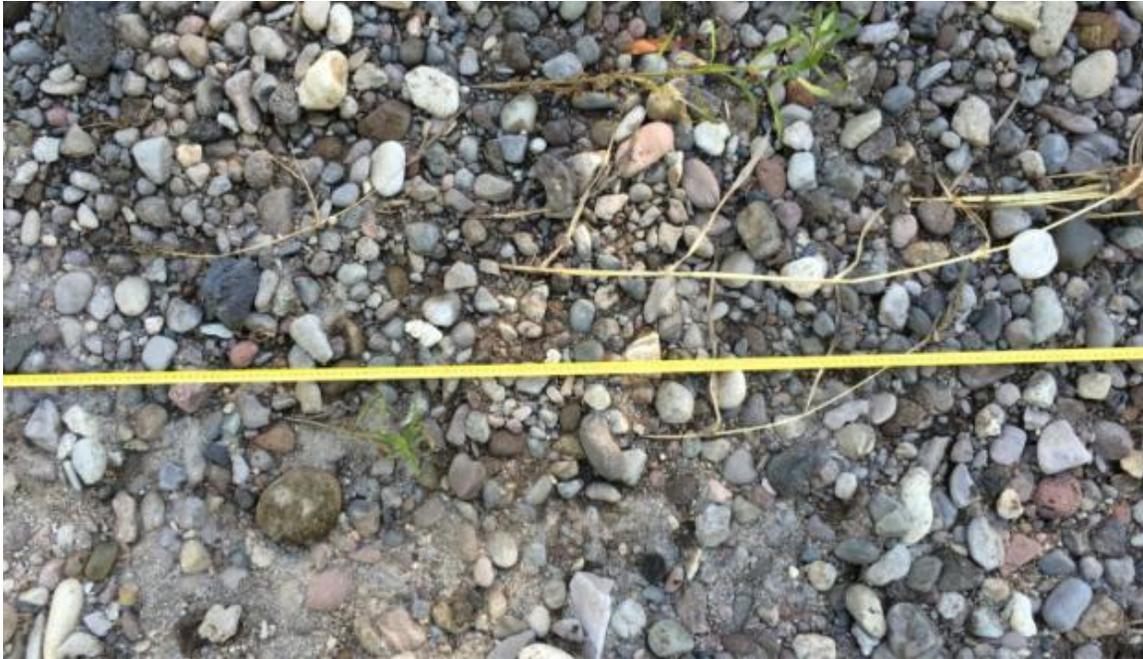
Approximately 75 feet upstream of the Gila Gage, along river right (west), an active mid-channel alluvial bar was observed. This bar was predominantly composed of cobbles, gravels, and sands and had a sparse cover of riparian grasses and shrubs, which had been laid down by a recent overbank flooding event of approximately 1,290 cfs (Photo 3). The downstream end of this bar marks the approximate location of the proposed surface water diversion intake alternative. A relatively low secondary flow channel, which showed evidence of a recent overbank flooding event, was also observed at this location (Photo 4).

Photo 3 Overview of the Gravel/Cobble Bar Located Along the Right (West) River Bank

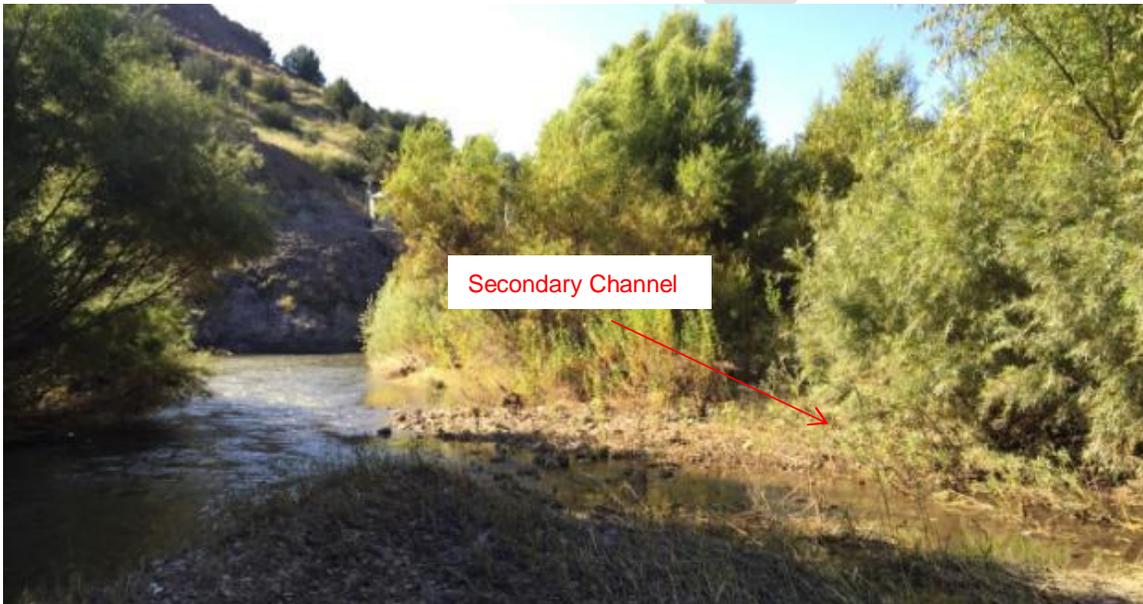
The entrance to this secondary channel connected to what appeared to be an elevated trench with intermittent earthen berms running along both sides. This is possibly the historic ditch used to deliver water to an abandoned agricultural field that was located on the alluvial terrace. Today however, the relative elevations of the Gila River channel and the ditch invert⁸ would not allow for the capture of water during lower flows in the river. Streamflow in the channel on the day of the field visit was 75 cfs. At this time the observed water surface elevation in the channel appeared between 1.5 to 2 feet too low to allow spilling into the elevated ditch.

Photo 4 Looking Downstream (Southeast) at the Downstream Extent of the Cobble/Gravel Bar and the Secondary Channel Inlet on River Right

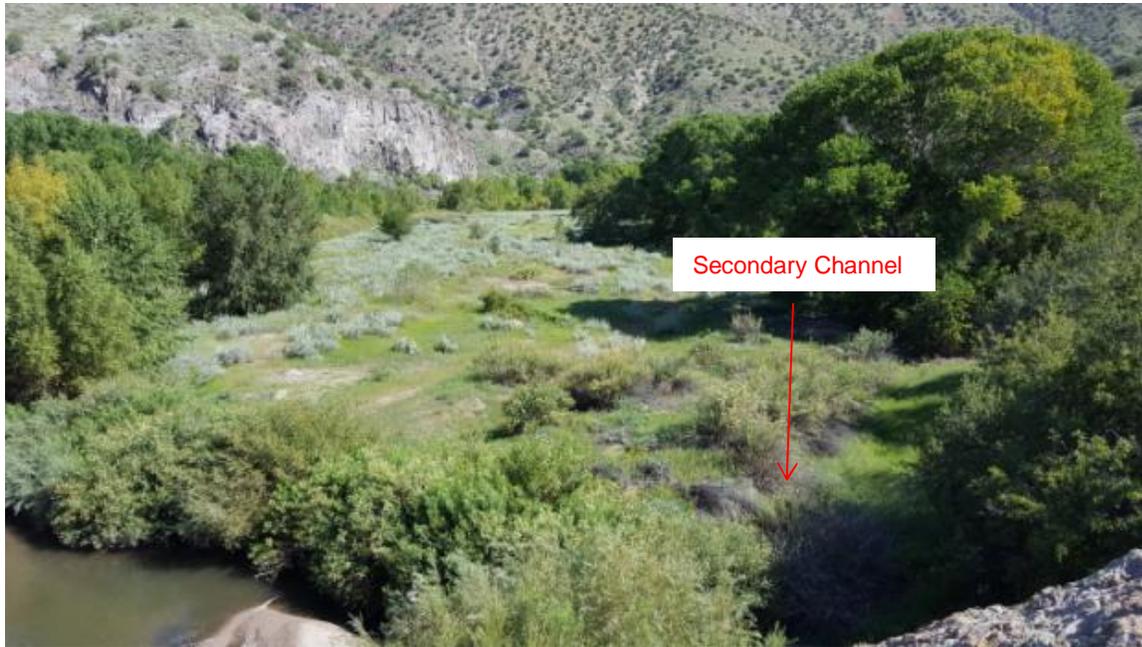
Upstream of the Gila Gage, along the left (east) side of the channel, an abandoned alluvial terrace was observed (Photo 5). Similar to two downstream alluvial terraces, an apparent secondary overflow channel could be identified along the perimeter of the floodplain, at the toe of the adjoining hill slope. This channel was differentiated from the remainder of the terrace surface by a distinct change in vegetation species and type.

Photo 5 Looking Upstream (North) at the Abandoned Terrace Located Along the Left (East) River Bank

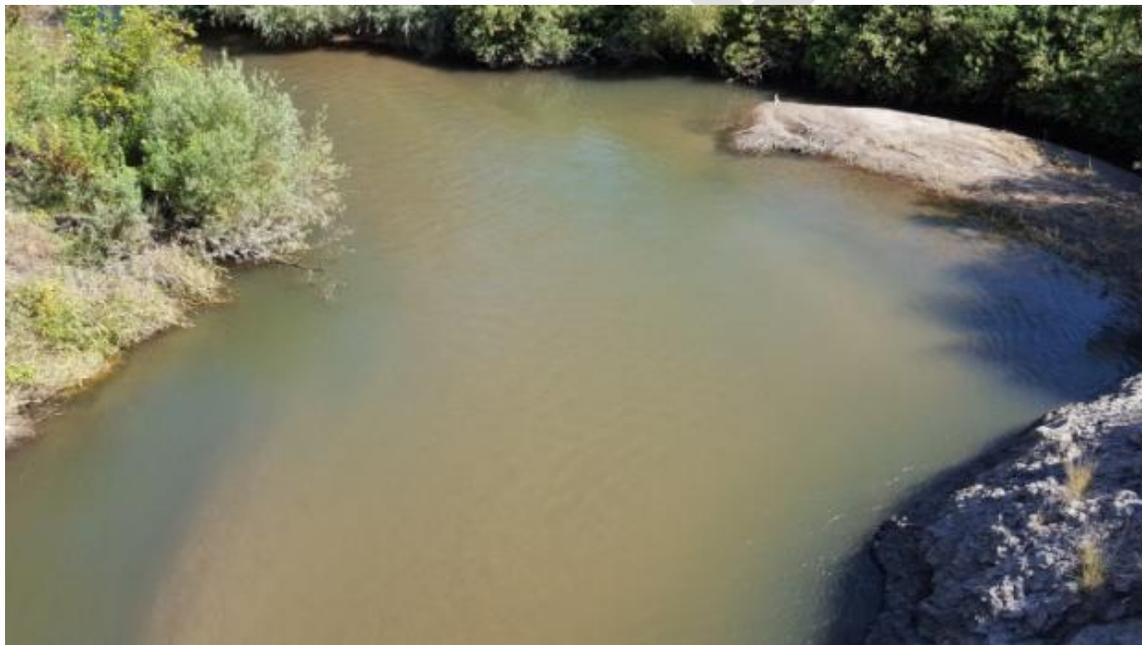
Photo 6 Looking Upstream (Northwest) from the Top of the Concrete Wall at the Gila Gage

Upstream of the stream gage, at the outfall of the elevated secondary channel, evidence of ongoing erosion/sedimentation was also observed (Photo 6). Here sandy deposits were observed below the water surface and evidence of ongoing erosion was identified at the outfall of the secondary channel. A distinct elevation difference, estimated between five and seven feet, was also observed between the invert of the river channel and the outfall of the elevated secondary channel. A Wolman pebble count was conducted on the riffle downstream of the stream gage (Photo 7), near the cross section established by the USGS cable car.

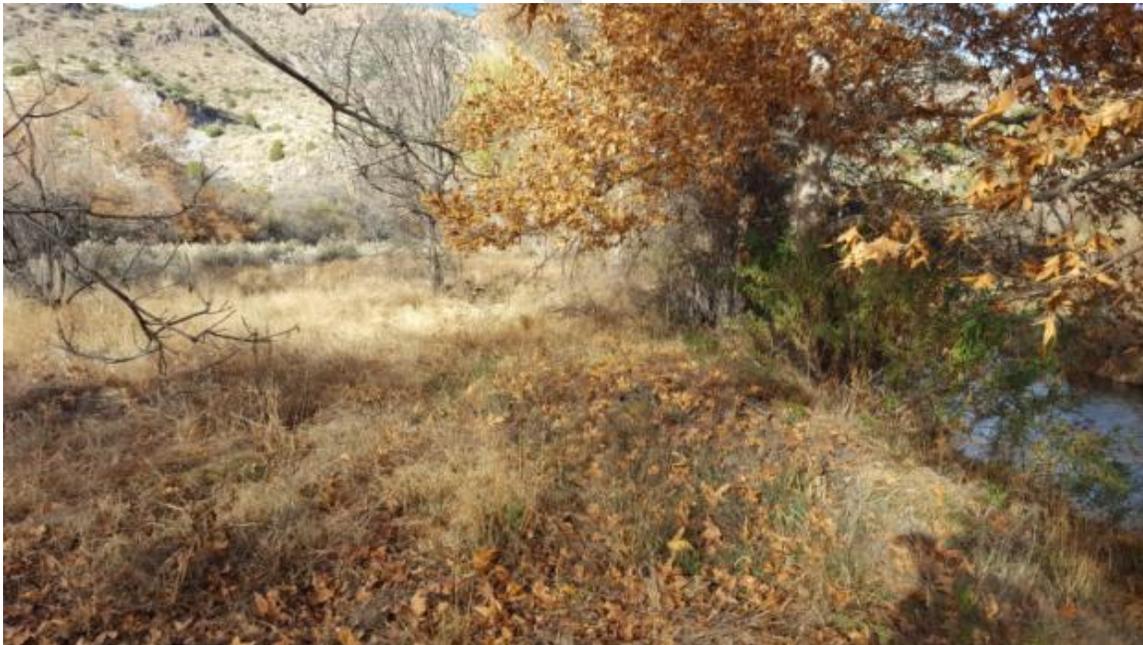
The stream channel was walked downstream of the Gila Gage for approximately 1/3 of a mile to assess the condition of the river bed and banks. Numerous bedrock outcrops were identified on river left in this reach along with more recent active channel bar formations. Along river right, the floodplain of the river was significantly elevated above the active channel and predominantly composed of upland vegetation species (Photo 8).

Photo 8 Looking Upstream (North) at the Floodplain along the Right Bank Downstream of the Gila Gage

Photo 8 shows one of the abandoned terraces on the left of the photo. Upland vegetation, such as rabbit brush, is evident in this field, along with dead riparian trees, indicating that the hydrology at this location has changed. The active channel is apparent on the right side of the photo. Growing along the active channel margin, a narrow band of thick riparian vegetation was observed. Evidence of the recent 1,290 cfs flooding event, occurring on September 9th 2016, could be seen by the laid down riparian vegetation (Photo 9), though this event did not achieve the stage of the adjoining floodplain. Willow and smaller (~12 inch diameter) cottonwood were observed growing near the water's

edge, while larger (~24-48 inch diameter) Cottonwood and Sycamore were observed at the elevation of the historic floodplain. Construction scars from historic levee activity were also seen on the floodplain along with abandoned corrals for livestock and fencing.

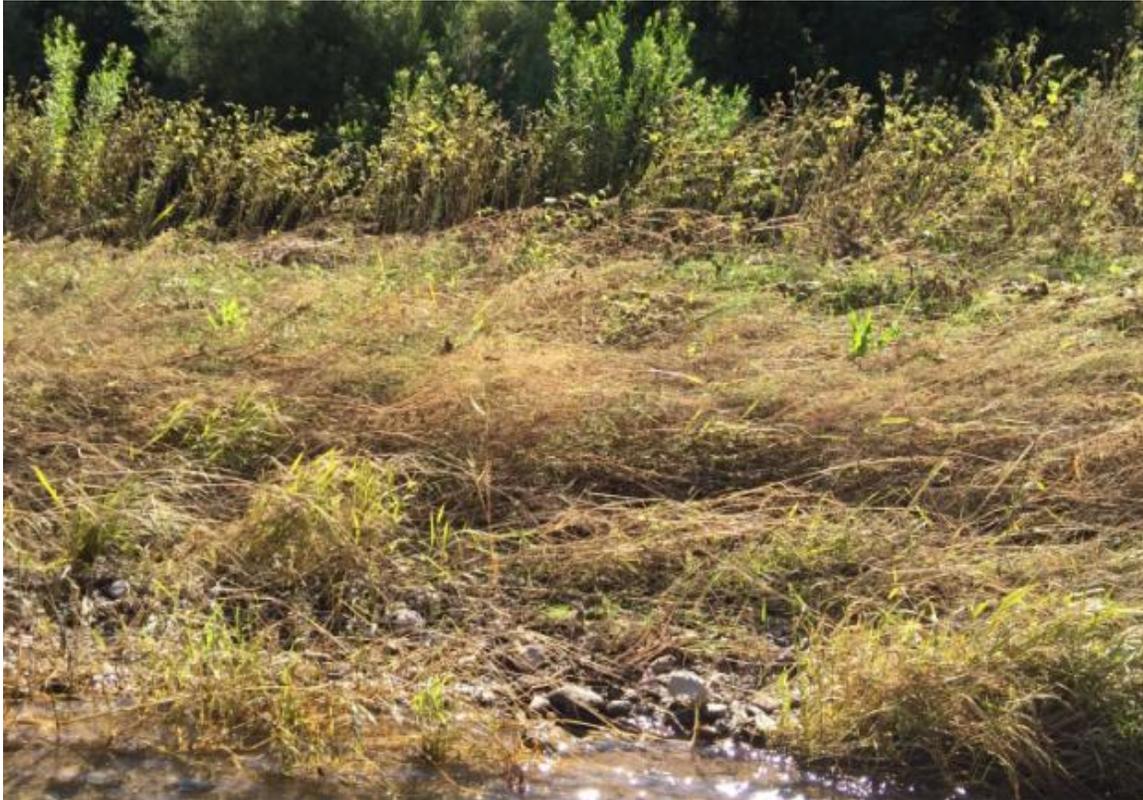
Photo 9 Looking to the West at Recently Laid Down Vegetation along Active Chanel Margin

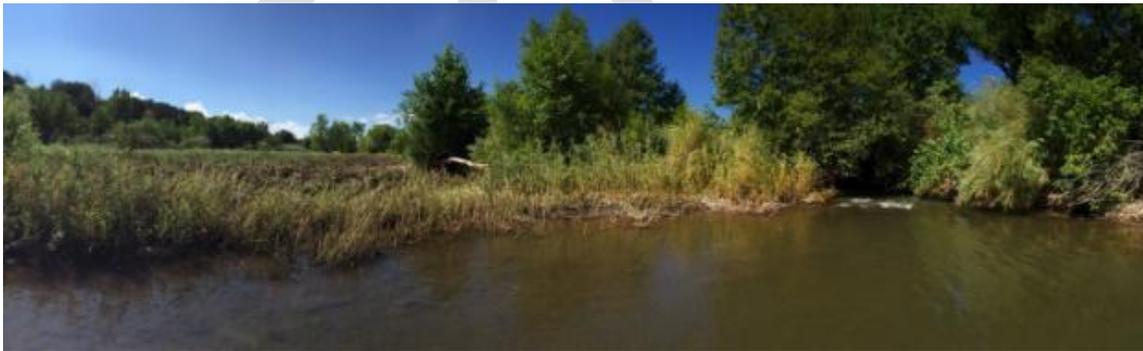
Photo 10 Looking Downstream (South) at Channel Bifurcation with the Elevated Historic Channel Alignment on Left Half of Image and Current Head of Incised Channel on the Right Half of the Image

Nearing the downstream end of the investigated reach, evidence of a historic channel avulsion⁹ and headcutting was observed. Here, the active channel bifurcates, making an abrupt 45 degree angle turn to the southwest away from what appears to have been a historic alignment of the channel (Photo 10). The difference in elevation between the active channel and the historic channel is estimated at between three and four feet. The composition of the historic channel bed appeared similar to that observed at the location of the Wolman Pebble Count at the Gila Gage (Photo 11). It could also be seen that a recent high flow event accessed the historic channel, as evidenced by recently deposited sediments and ponding (Photo 12).

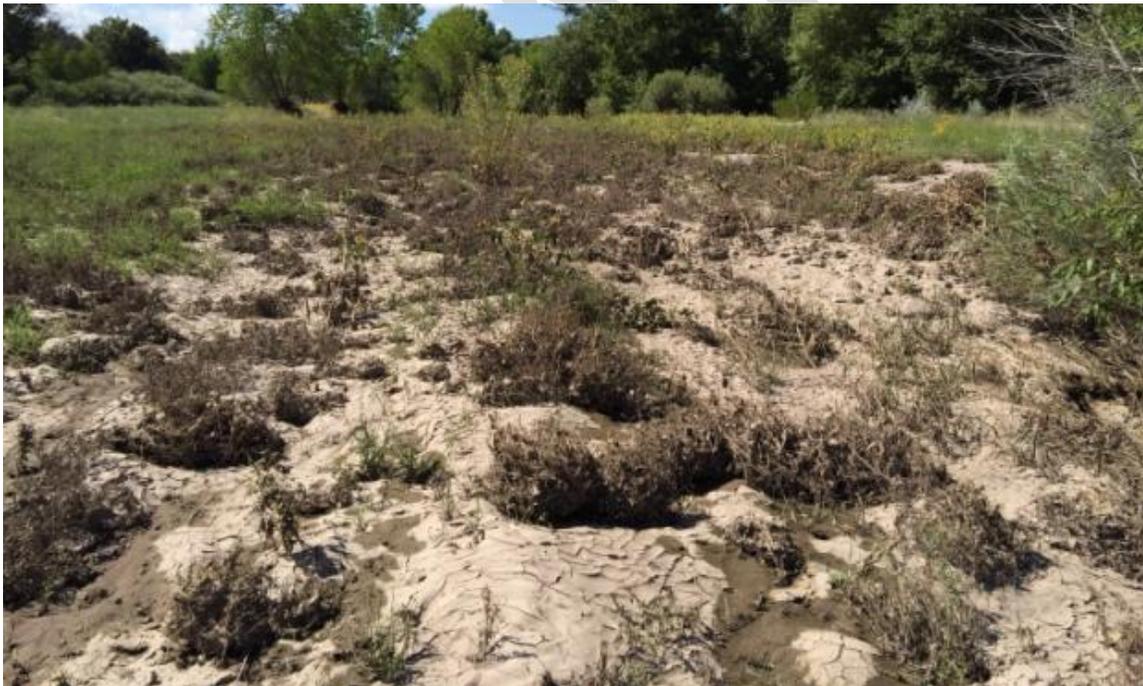
Photo 12 Looking Downstream (South) at the Historic Channel Alignment of the Gila River, with the Active Channel Located Approximately 20 feet to the Right of the Photo

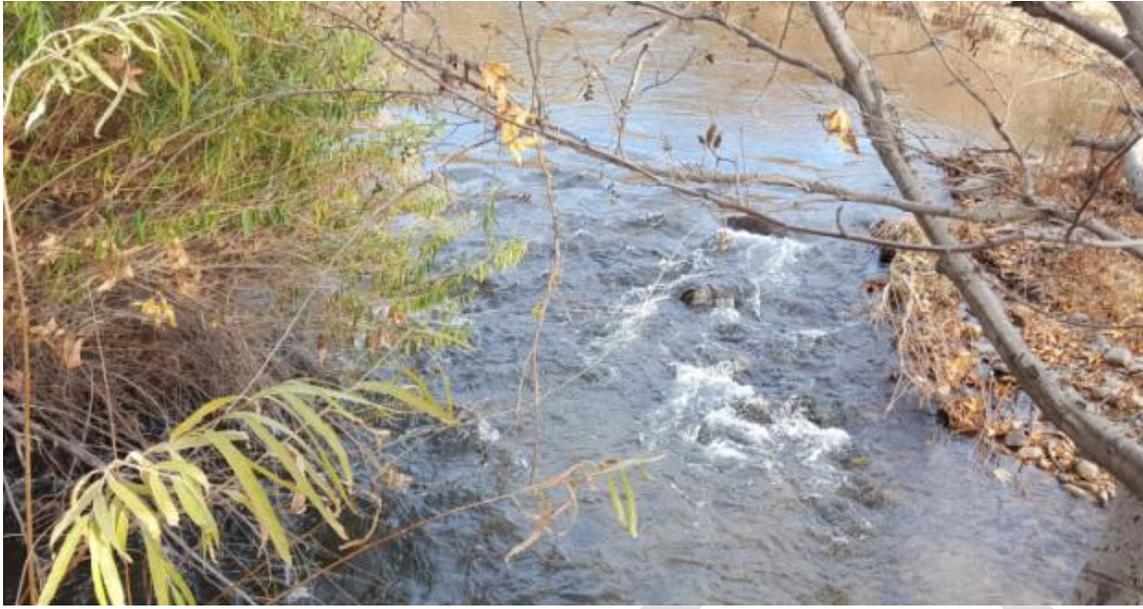
Below the entrance of the active channel at the bifurcation point a pseudo-stable headcut was observed. This headcut was identified by a locally over-steepened riffle, composed of uncharacteristically coarse sediments, which created an audible sound as the river rapidly descended approximately two feet over small boulders (Photo 13). At this location, the right bank is being impinged upon by the flowing channel and actively eroding below a large Sycamore tree. Undercutting of the tree has become so severe, the main trunk of the tree has fallen over creating a bridge over the channel and several smaller suckers now grow vertically from its base.

Photo 13 Looking North from Above at the Pseudo-Stable Head of the Incised Channel

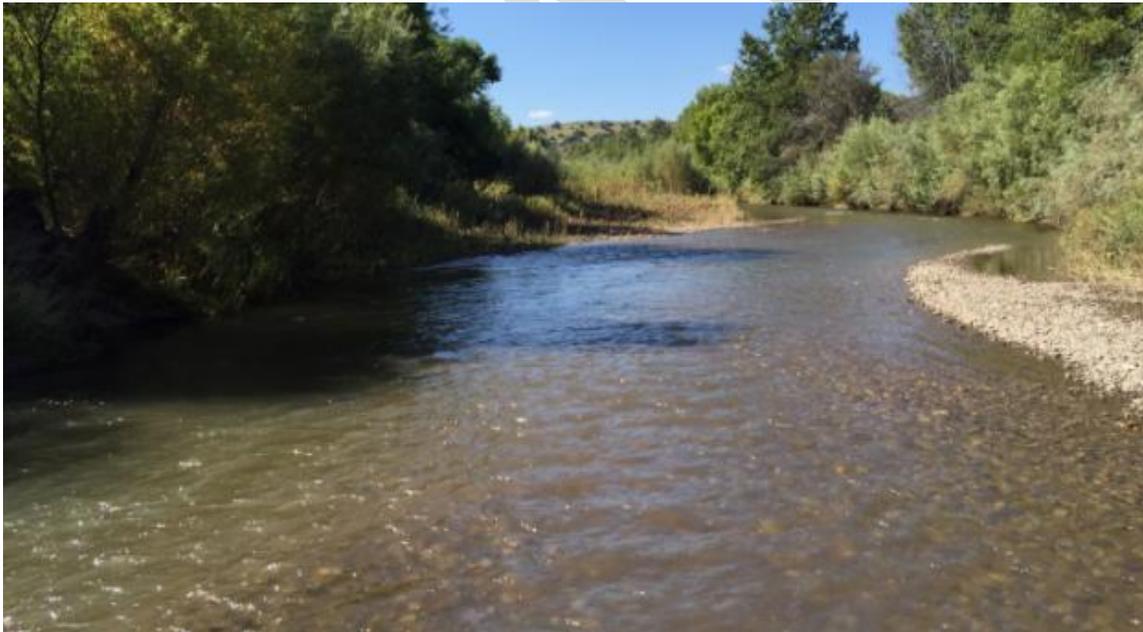
Upstream of this avulsion the flowing channel ranged from 30 to 50 feet in width and one to three feet in depth at the time of the field visit (Photo 14). However, downstream in the incised reach the channel narrowed to roughly 20 to 30 feet in width and the depths increased to between two and four feet (Photo 15).

Photo 14 Looking Downstream at the Reach Just Upstream of the Bifurcation Point

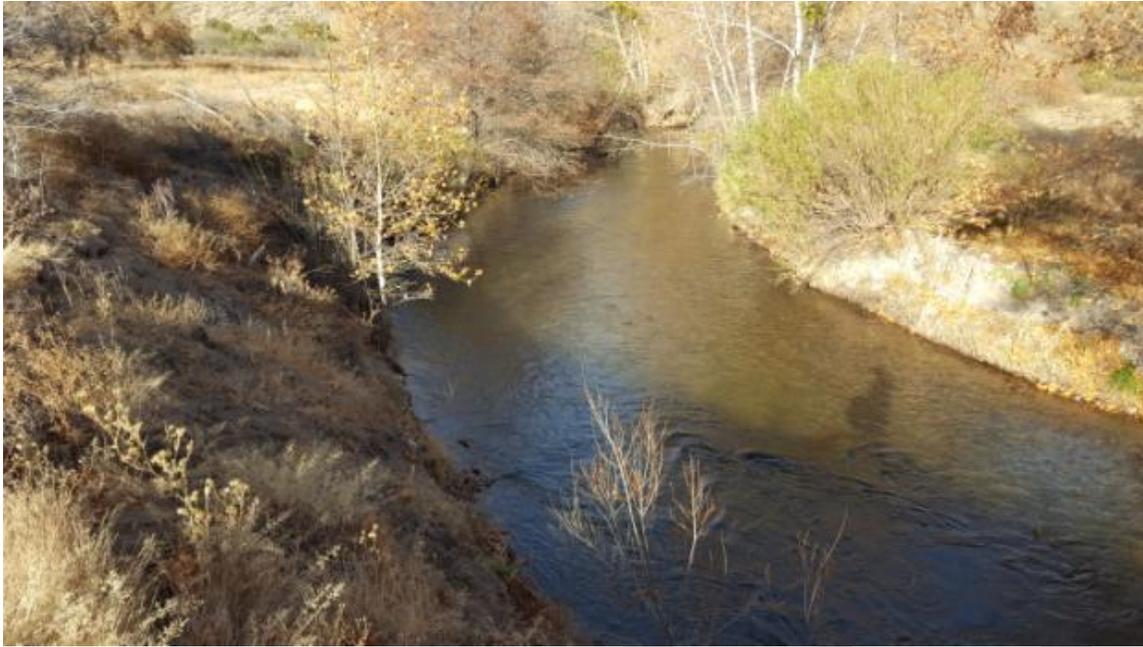
Photo 15 Looking Upstream at the Incised Reach from Downstream of the Bifurcation Point

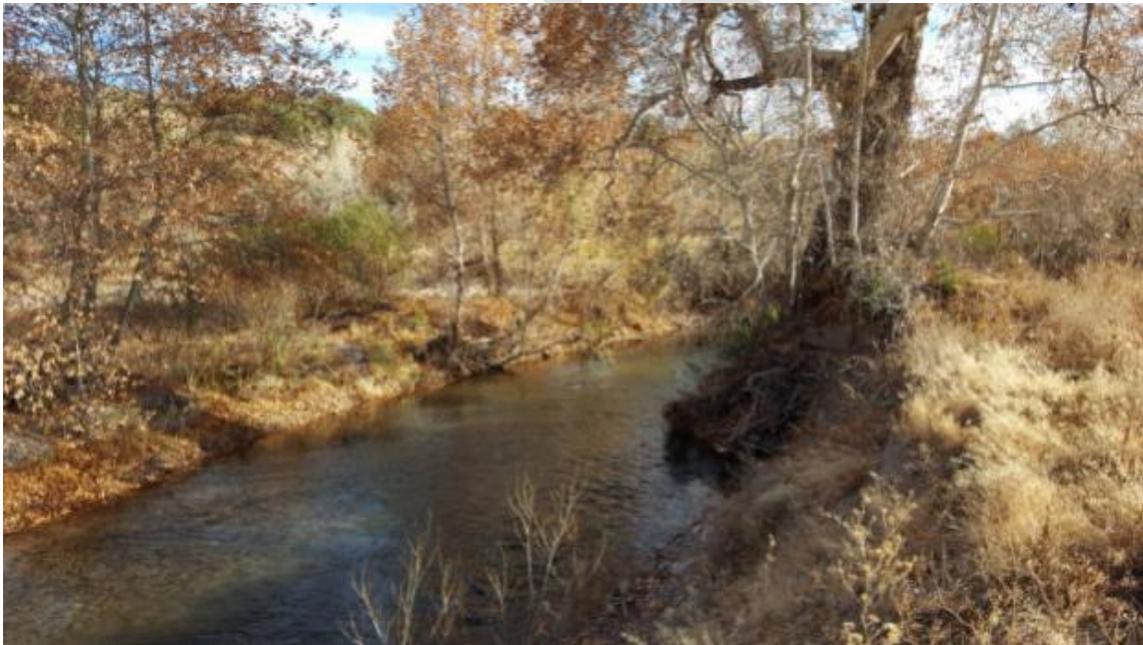
The banks within the incised reach also appeared excessively steep and unstable, particularly on the right where the bank is approximately 15 feet in height. Here, mature deciduous Sycamore trees were perched along the top of the right bank, overhanging the channel with undercut exposed roots (Photo 16). Several smaller Cottonwood trees and willow were also observed at the toe of the slope, although the majority of the bank was failing.

Photo 16 Looking Downstream at the Incised Reach from Downstream of the Bifurcation Point

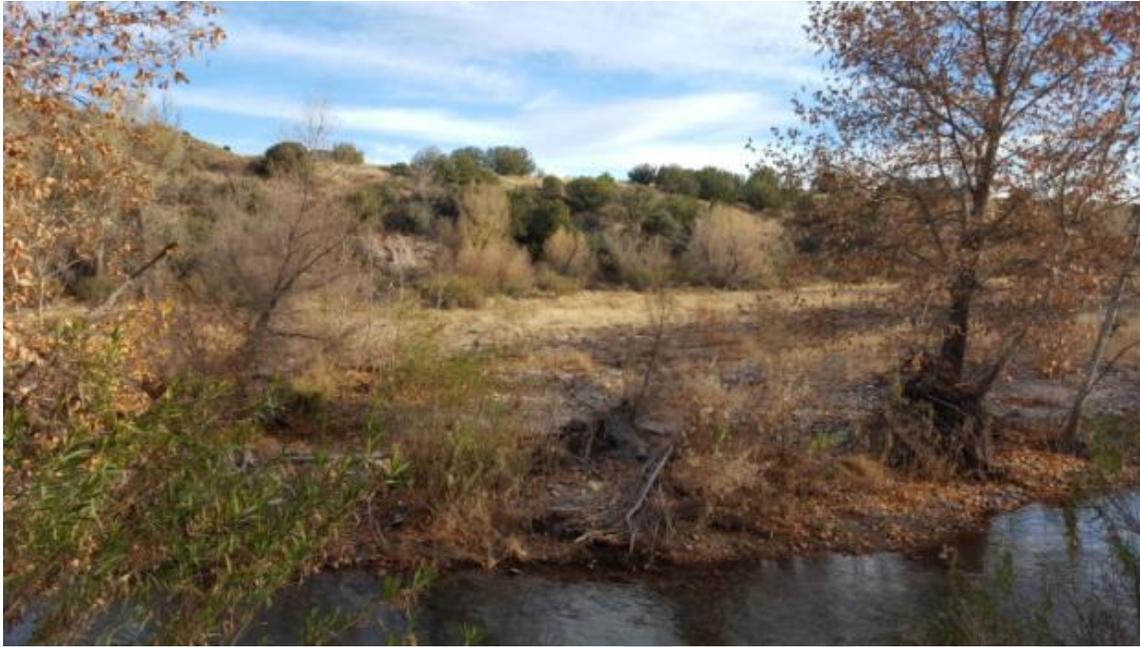
Along the left (east) bank a smaller two foot bank was observed, stepping down from the elevation of the historic channel. Outside the active channel margin, the floodplain is composed of imbricated cobble and vegetated predominantly by upland species (Photo 17).

Photo 17 Looking East across the Incised Reach at the Historic Channel Bed that Today Composes the Active Channel Floodplain

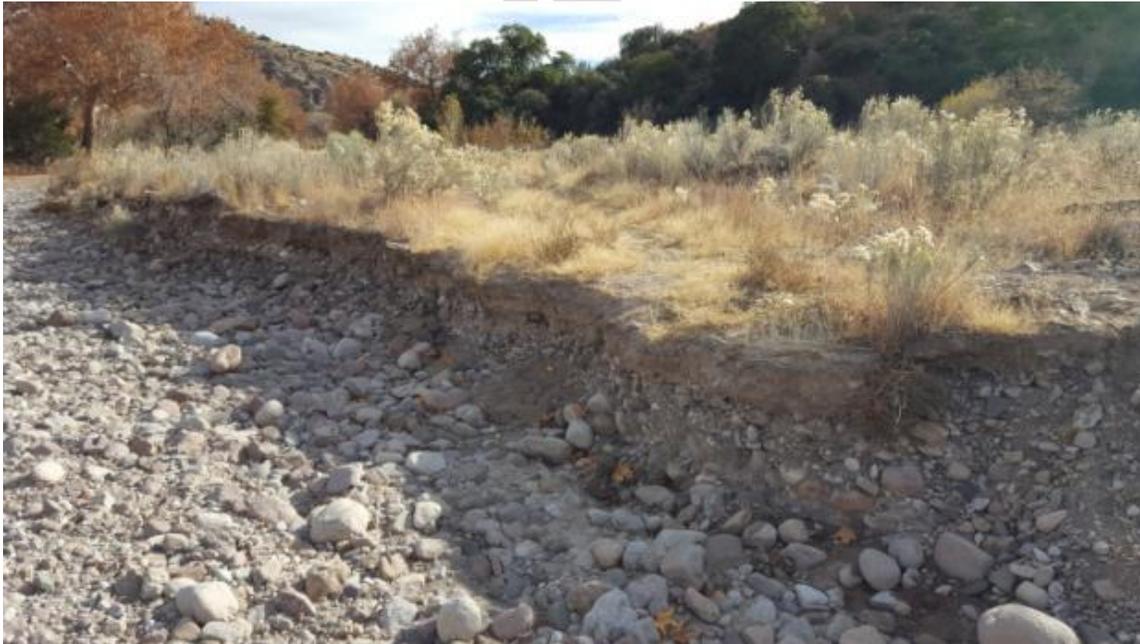
Access to the site is further complicated by an unimproved crossing of Mogollon Creek, which is capable of producing large discharge events and is prone to severe bank erosion and channel avulsion. During the fall of 2016 the banks of Mogollon Creek were two to four feet in height and vertical at the crossing (Figure 13). Gage records of Mogollon Creek indicate peak discharges up to 10,800 cfs. During typical flow conditions the channel is often dry and an at-grade crossing with access improvements along the banks may be sufficient for future site access, however access during high flows will be impractical.

Figure 13 Vertical Bank at the Existing Crossing of Mogollon Creek
