Quantifying Leaks with Acoustic Loggers

New Mexico Office of the State Engineer Water Use and
Conservation Bureau

May 21, 2010

AMEC Earth and Environmental & Miya Arison Group

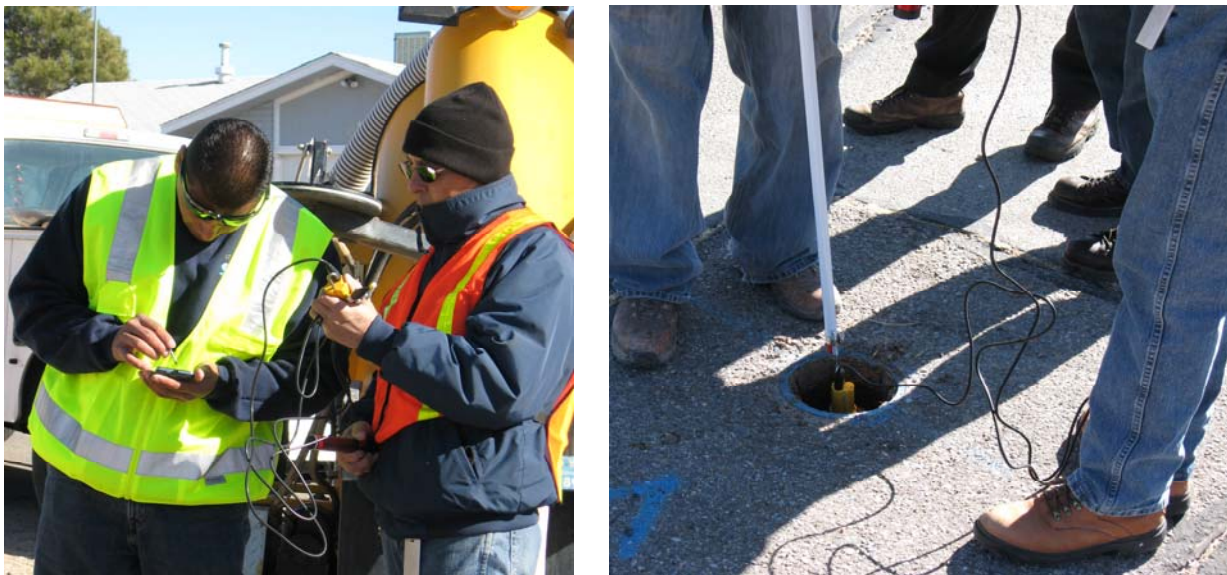
Figure 9: Rio Rancho staff programming data into the PDA and placing a logger on a water valve.

The implementation of the program occurred in the Fall and Winter of 2009-2010 with a two-day field visit to each of the cities. The initial visit involved training the utility personnel assigned to the project. The training included: education on acoustic logger leak detection, programming the equipment, deployment of the acoustic loggers, patrolling to determine how the system was operating and collecting, downloading, and assessing data. It is estimated that a couple of hours were spent on each of the training areas. The most time was spent on deployment, with the least time spent on assessing data. NMOSE and contractors presented a short introduction to utility field staff involved in the project. The majority of the training occurred in the field as the loggers were deployed. An effort was made to allow all interested staff a chance to work the PDA and to program and deploy loggers (Figure 9).

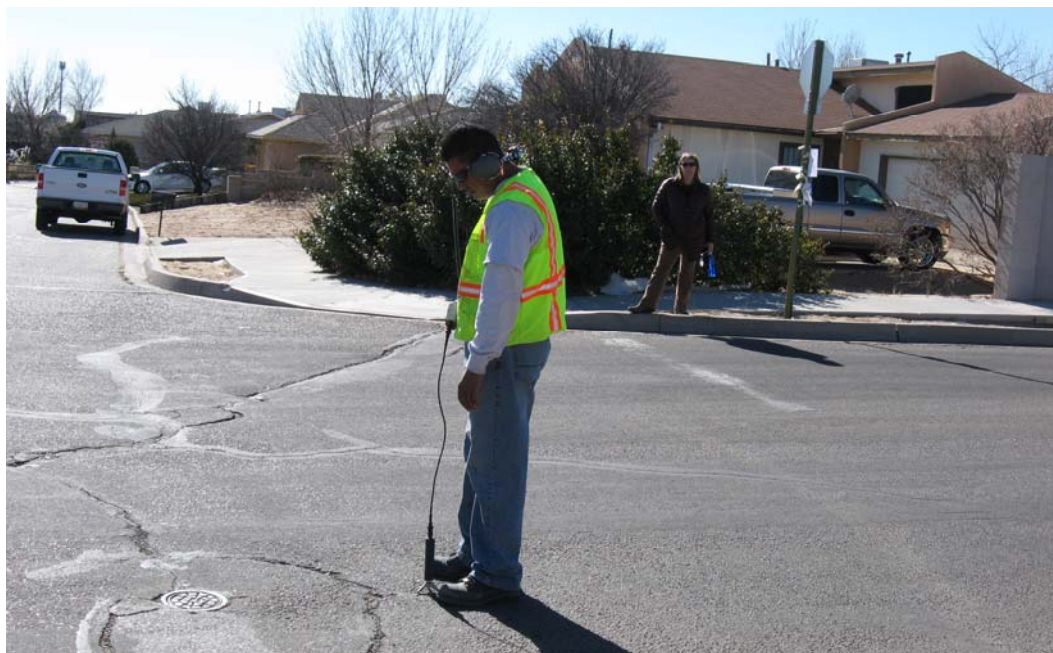
Figure 11: Rio Rancho personnel using ground microphone to listen for leak.

The supplemental visits included additional deployment of the remaining loggers, patrolling assistance, questions concerning database management, work with data interpretation, site investigations, ground microphone work (Figure 11) and general trouble shooting.

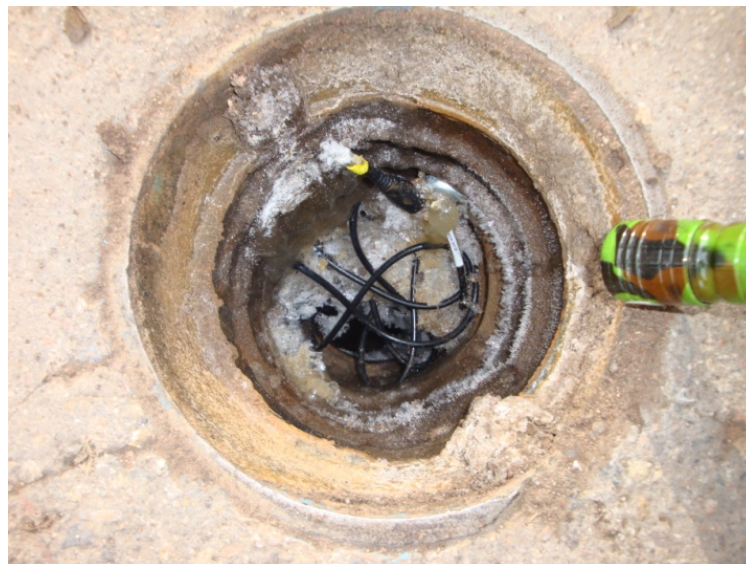
Figure 13: Ice filled valve box in Las Vegas, NM

Finally, it has been reported in two of the three cities that about four to six months into the program the majority of the loggers have either turned themselves off or had a programming shift on the read times. Field crews reported that they would receive signals for 90 to 100 percent of the loggers during one patrol and then the next patrol only get 5 or 10 percent. The loggers that were not sending signals were pulled and swiped to be restarted and redeployed. This resets the loggers, deleting accumulated data. However, the loggers are working once again. At this time it is unknown why this is happening. Both cities experiencing this problem had extremely cold, harsh winters (Figure 13). NMOSE and the cities involved will continue to investigate this issue. An early hypothesis is that the cold weather weakens the battery causing the unit to shut off to preserve the data.

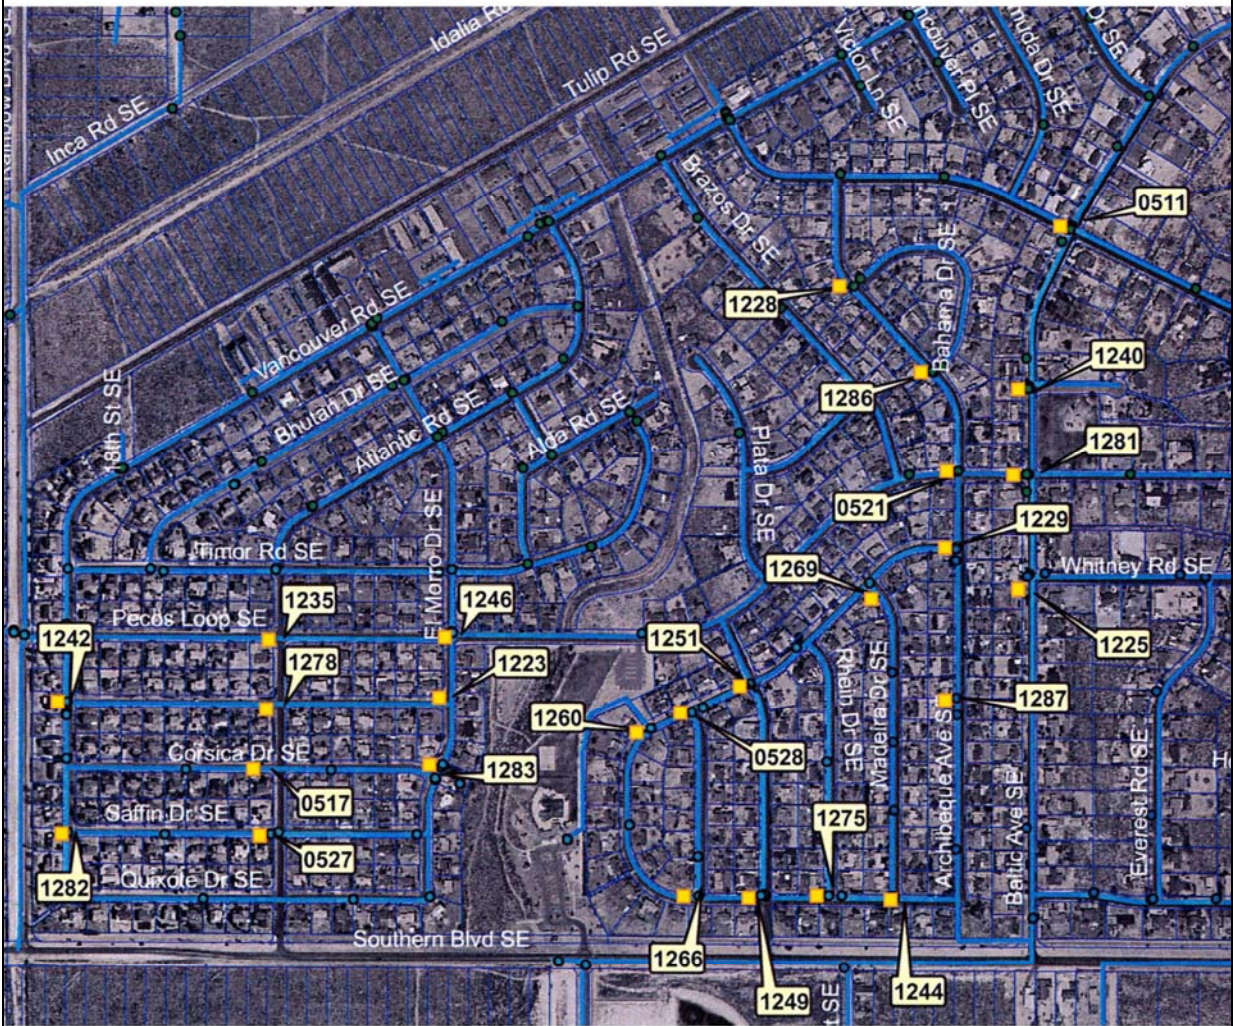
Rio Rancho Logger Locations

Rio Rancho found leaks both while installing the loggers and as a result of the acoustic logging equipment. During the original deployment in December 2009, utility staff observed water leaking from a recent asphalt patch. This was called in to be placed on the utility's leak reporting 'board'. Four other leaks were identified with the equipment. A logger detected the first leak on Zaragoza Road and Wagontrain Road. The utility used a ground microphone for pinpointing and the leak was located in a meter box. At a second location, the Environmental Programs Manager recognized downloaded data that looked suspicious (level was at a mid-range) but it did not alert as a leak (L) and decided to investigate the area. The second leak was discovered also in a meter box. For the third leak at a third location, the level data looked suspicious with subsequent readings showed the level decreasing. The leak surfaced prior to further investigation. It was determined that as the leak grew larger the noise level decreased resulting in no alert by the logger. The fourth leak was on a service line and surfaced two days following deployment. The leaks that have surfaced have been repaired. Additional leaks continue to be found by the loggers but have not yet been categorized. A leak detected in December has not yet been repaired by the date of this report.
