Quantifying Leaks with Acoustic Loggers

New Mexico Office of the State Engineer Water Use and
Conservation Bureau

May 21, 2010

AMEC Earth and Environmental & Miya Arison Group

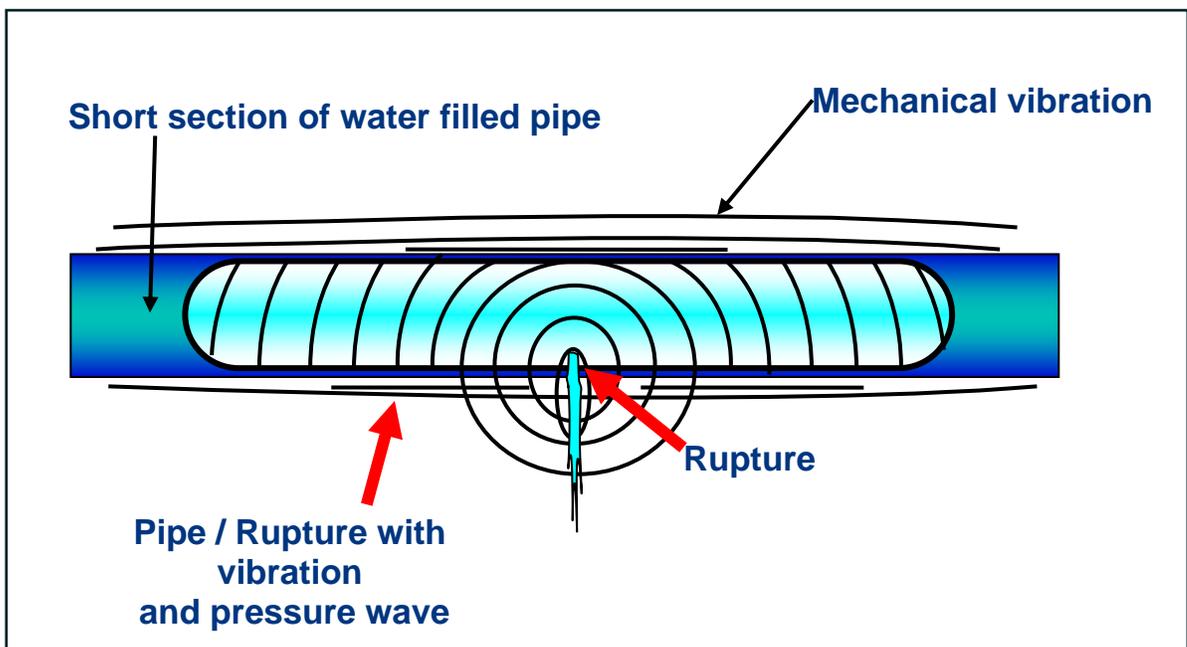
Water escaping from a hole or rupture in a pipe that is transmitting water under pressure will produce a noise vibration (Figure 5). Depending on subsurface conditions the water from a leak either moves upward to the surface where it can be observed or flows downward into a permeable sub-surface layer and is not visible or observed.

Figure 5: Diagram showing vibrations a leak makes (modified from FCS, 2009)

The acoustic loggers attached to a connection point have the ability to audibly detect the pressure or mechanical vibrations emitted by the leaking pipe and record them. The data is transmitted via radio signals to a receiver that then transmits the data via blue-tooth technology to the personal digital assistant (PDA) or computer. The data are then placed into a database (see example in Table 5). The information identifies the logger, a location, the date of the reading, the status of leak mode and the level and spread of the noise heard. Each system on the market handles the data reading and output slightly differently, but they are all fundamentally the same.

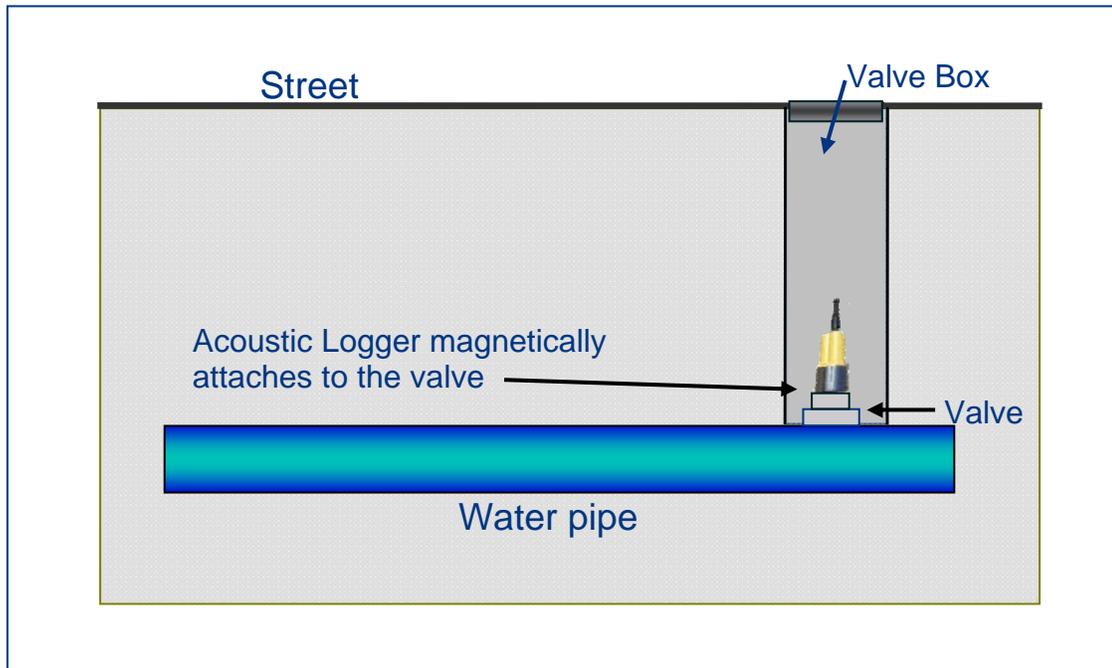
The loggers are small-scale, self contained devices that magnetically attach to distribution valves, fire hydrants, and key junctures on the water main (Figure 6). At night or during slow water use periods they activate, listen for and ‘pick up’ vibrations that occur in the pipeline. The preset program within the logger analyzes the data to evaluate whether a leak is possible. If no leak is apparent, the signal transmitted indicates normal background conditions and shows no alert. If a suspect leak is detected, an alert is displayed notifying utility personnel of a possible leak condition.

Figure 6: Diagram depicting placement of logger on a valve (Modified from FCS, 2009)

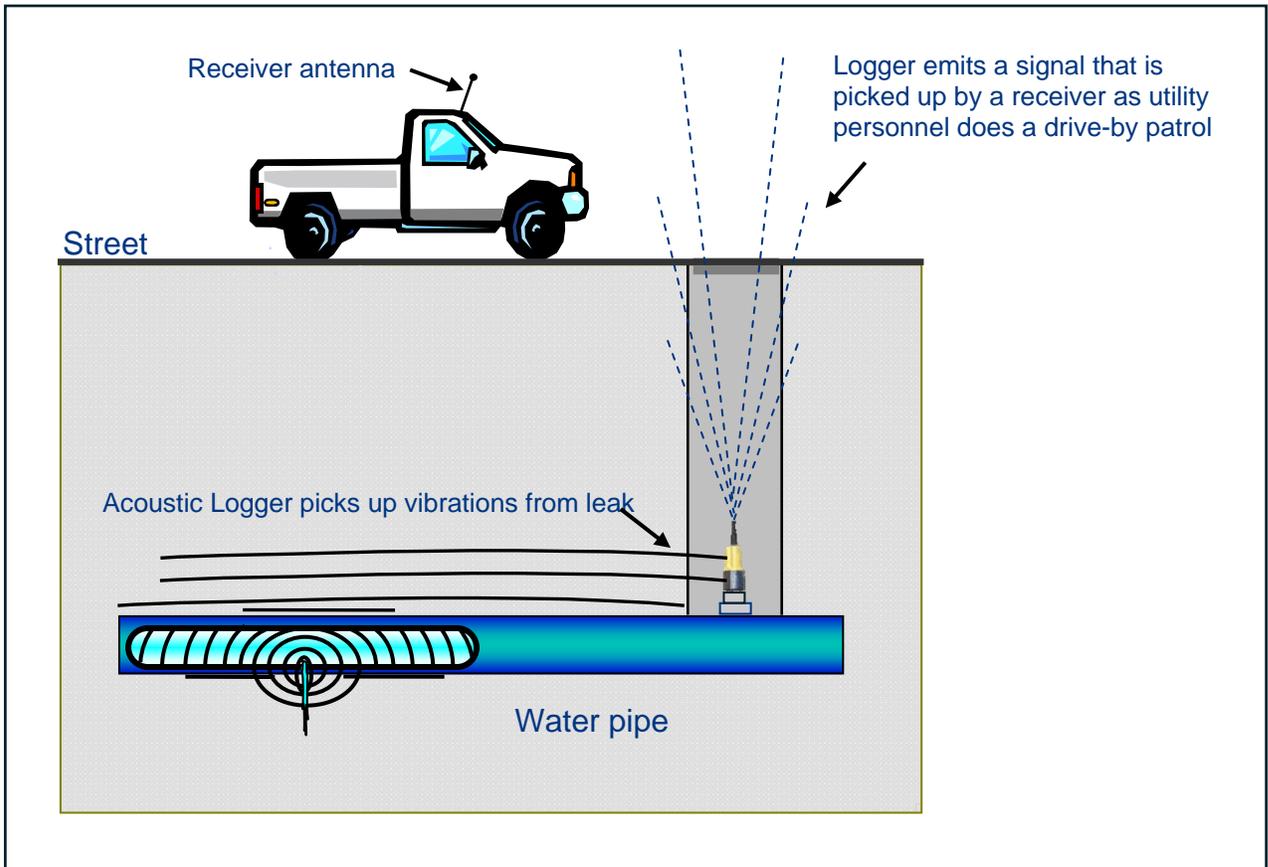
The loggers transmit the data via radio signals to a receiver, located in either maintenance or meter reader truck as they drive along their route (Figure 7). The truck’s drive-by schedule can be set according to the community’s water system needs. When evaluating schedule options, utilities should consider the estimated quantity of leaks, the availability of staff and the need to recover lost water. Patrolling can be done daily, weekly, bi-monthly etc; communities with large losses or older systems can conduct frequent patrolling, while other cities under normal circumstances might rely on the regular meter reading routes. The transmitted data from each logger can then be viewed on a PDA or downloaded to a computer depending on which system is purchased. If an area has been cleared of leaks the loggers can be picked up and moved to a new locality. This technique is known as a ‘lift and shift’.

Figure 7: Diagram of how a receiver picks up the data from the logger as utility personnel drive by

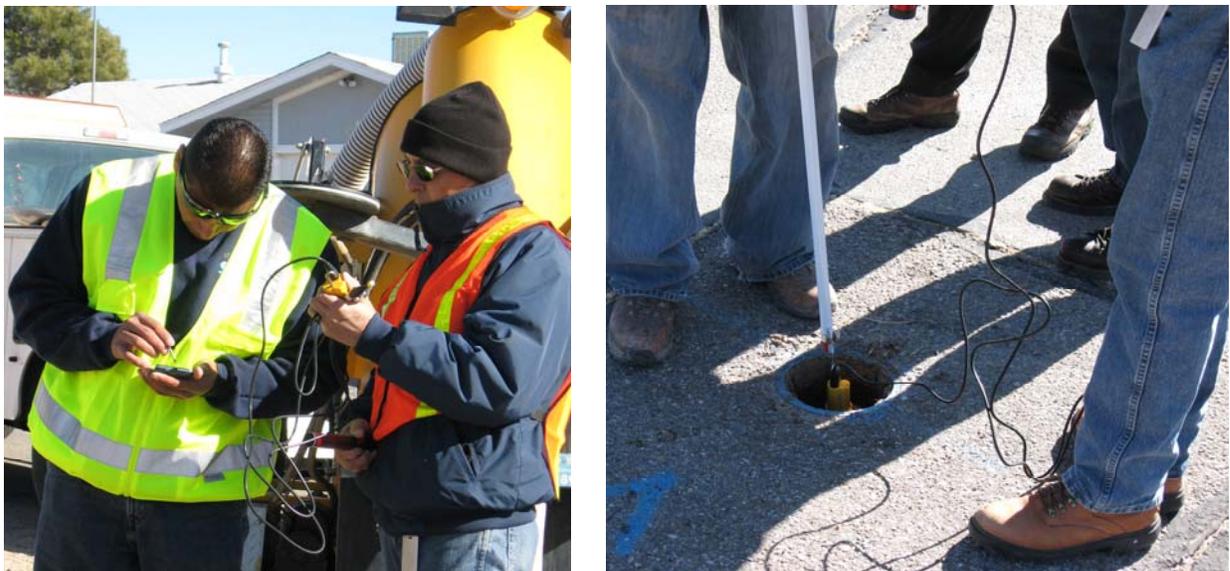
The implementation of the program occurred in the Fall and Winter of 2009-2010 with a two-day field visit to each of the cities. The initial visit involved training the utility personnel assigned to the project. The training included: education on acoustic logger leak detection, programming the equipment, deployment of the acoustic loggers, patrolling to determine how the system was operating and collecting, downloading, and assessing data. It is estimated that a couple of hours were spent on each of the training areas. The most time was spent on deployment, with the least time spent on assessing data. NMOSE and contractors presented a short introduction to utility field staff involved in the project. The majority of the training occurred in the field as the loggers were deployed. An effort was made to allow all interested staff a chance to work the PDA and to program and deploy loggers (Figure 9).

Figure 9: Rio Rancho staff programming data into the PDA and placing a logger on a water valve.

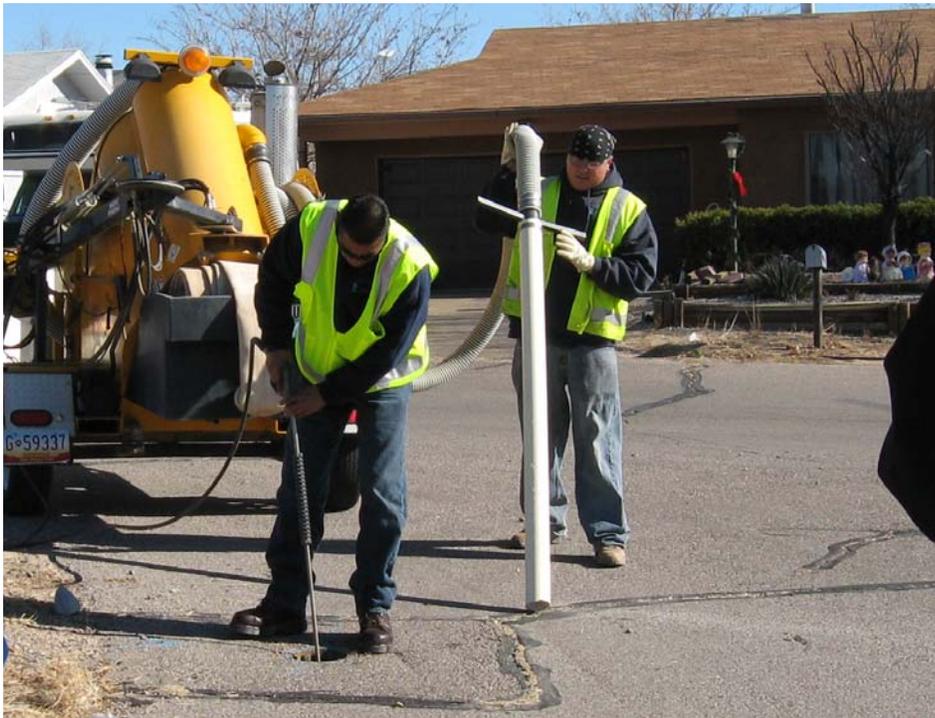
Figure 10: Personnel cleaning out valves prior to logger deployment

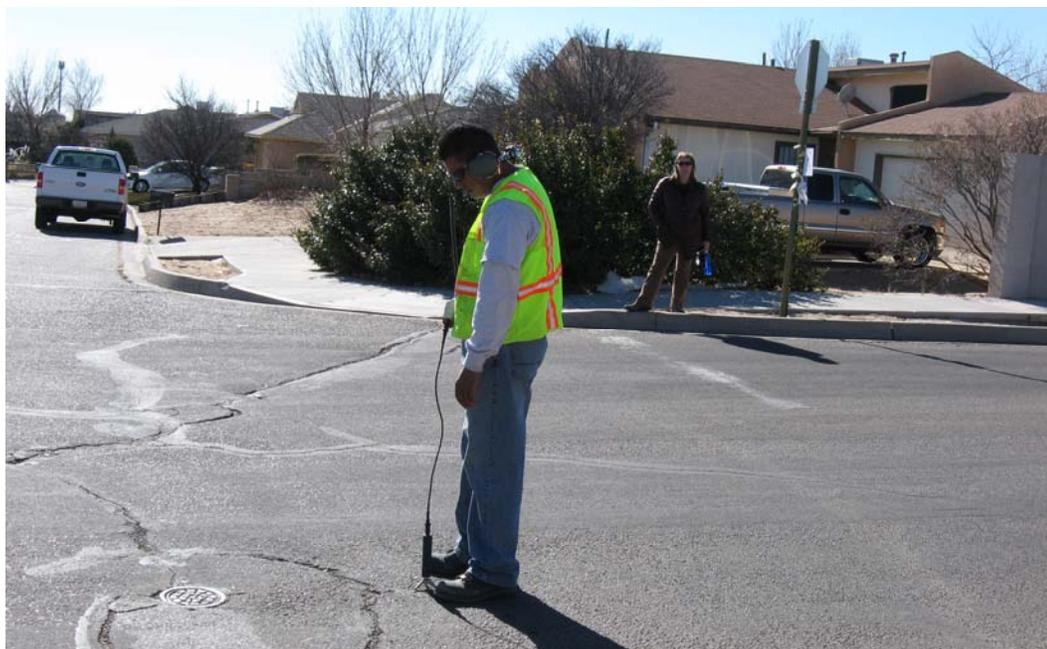
The supplemental visits included additional deployment of the remaining loggers, patrolling assistance, questions concerning database management, work with data interpretation, site investigations, ground microphone work (Figure 11) and general trouble shooting.

Figure 11: Rio Rancho personnel using ground microphone to listen for leak.

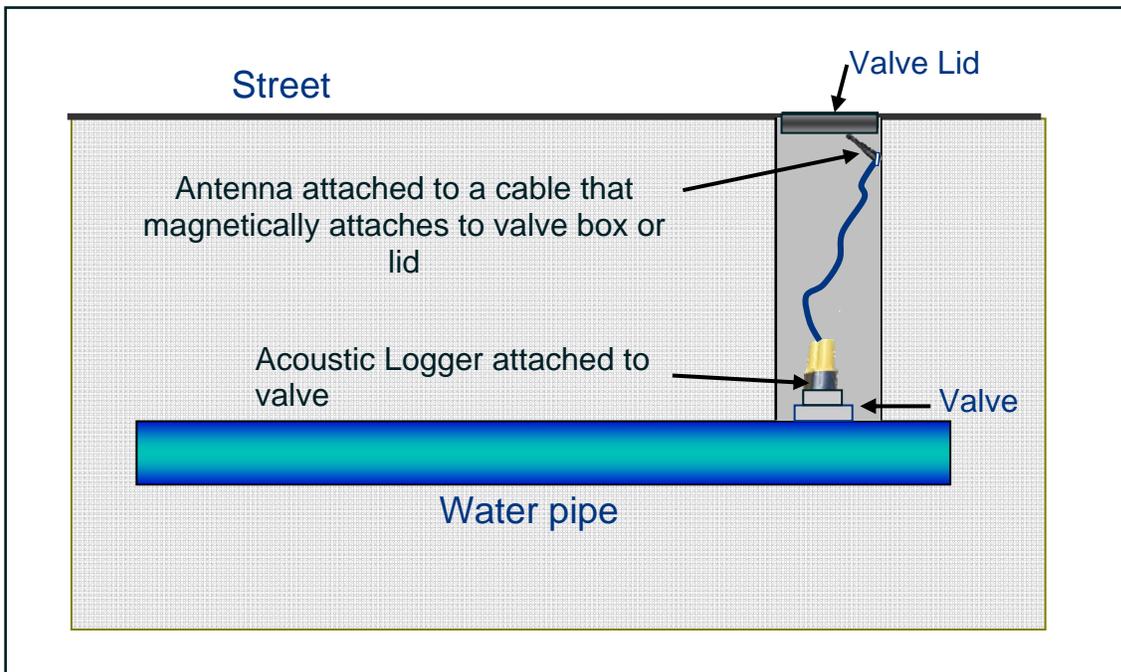
The equipment problem was centered on the standard antennas. These antennas are about 3 inches long and attach directly to the logger. The loggers are placed on valves which are located in vaults one to four feet below the ground surface. A large percentage of the radio signals did not make it out of the valve box. The antenna problem was resolved by removing the antennas from the loggers and attaching them to long extension cables (10 feet). The cables connected the loggers to the antennas so the antennas could be placed closer to the ground surface, just beneath the valve lid (Figure 12). The antennas are also unable to transmit if they are under water. The higher position in the valve box limited the reception problem to all but the most severe weather events. Ruidoso's heavy snow pack provided for a couple of snow melt events that put even the raised antennas under water for a short period of time. Utility personnel also improved drive-by reception by placing the receiving antenna on the roof of the patrolling vehicle instead of on the hood. This worked well when driving slowly and directly over a valve box. On occasion, it was still necessary to stop, get out and lift valve box lids in order to get a reading. This was usually due to soils becoming hard packed around the lid and sealing it from transmissions.

Figure 12: Diagram showing the antenna attached to logger with a cable and placed under valve lid.

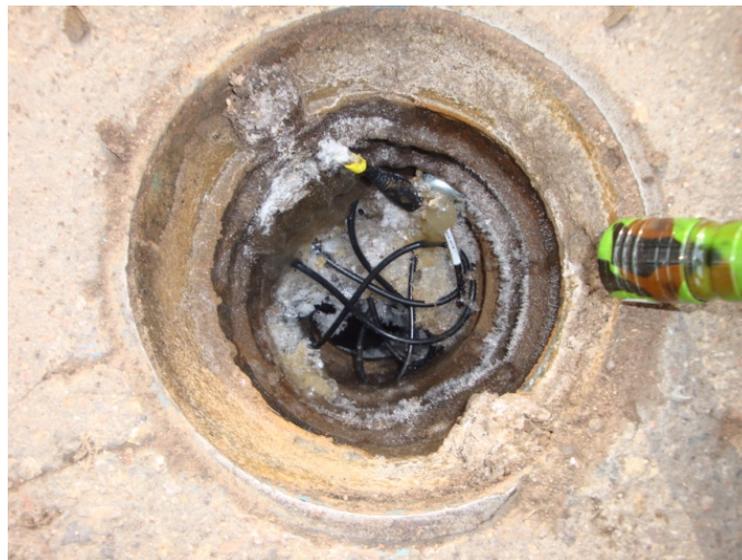
Finally, it has been reported in two of the three cities that about four to six months into the program the majority of the loggers have either turned themselves off or had a programming shift on the read times. Field crews reported that they would receive signals for 90 to 100 percent of the loggers during one patrol and then the next patrol only get 5 or 10 percent. The loggers that were not sending signals were pulled and swiped to be restarted and redeployed. This resets the loggers, deleting accumulated data. However, the loggers are working once again. At this time it is unknown why this is happening. Both cities experiencing this problem had extremely cold, harsh winters (Figure 13). NMOSE and the cities involved will continue to investigate this issue. An early hypothesis is that the cold weather weakens the battery causing the unit to shut off to preserve the data.

Figure 13: Ice filled valve box in Las Vegas, NM

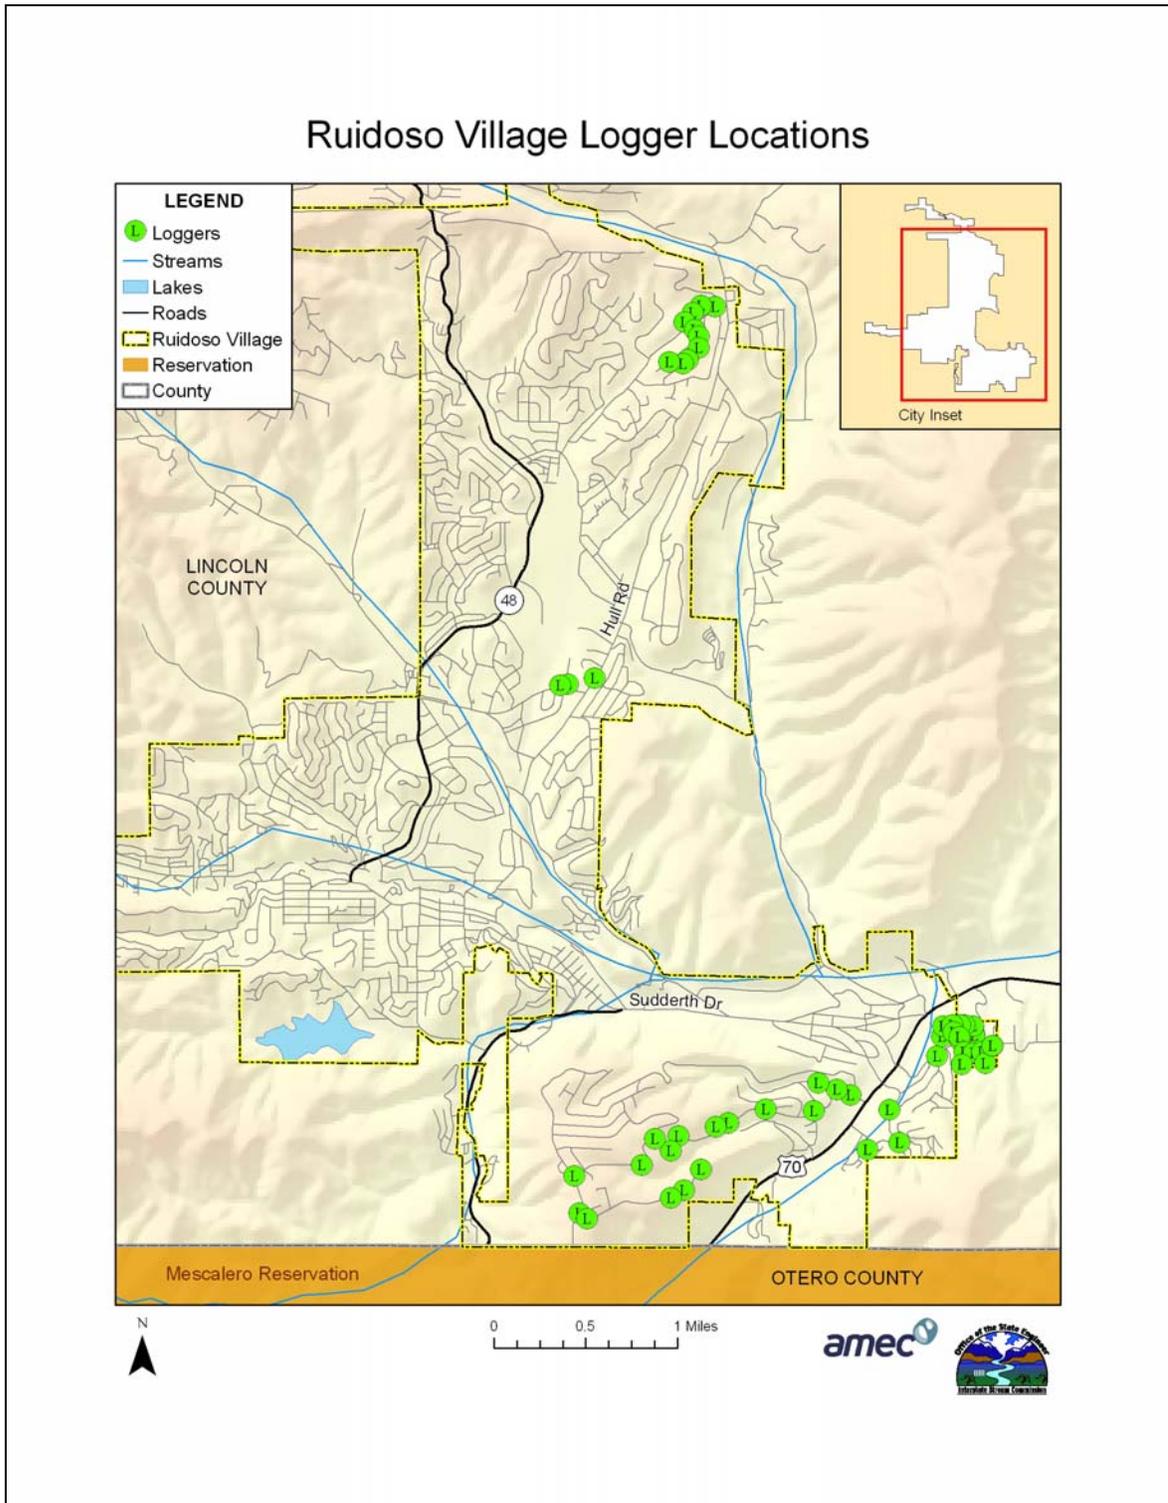
Figure 14: Locations of logger placement during the initial and subsequent deployments in Ruidoso, NM.
