Draft Gila River Conceptual Diversion Assessment

Project Reference: NMCAP 30% Design
Project Number: 60504989

January 6, 2017

Prepared For: New Mexico
Interstate Stream Commission

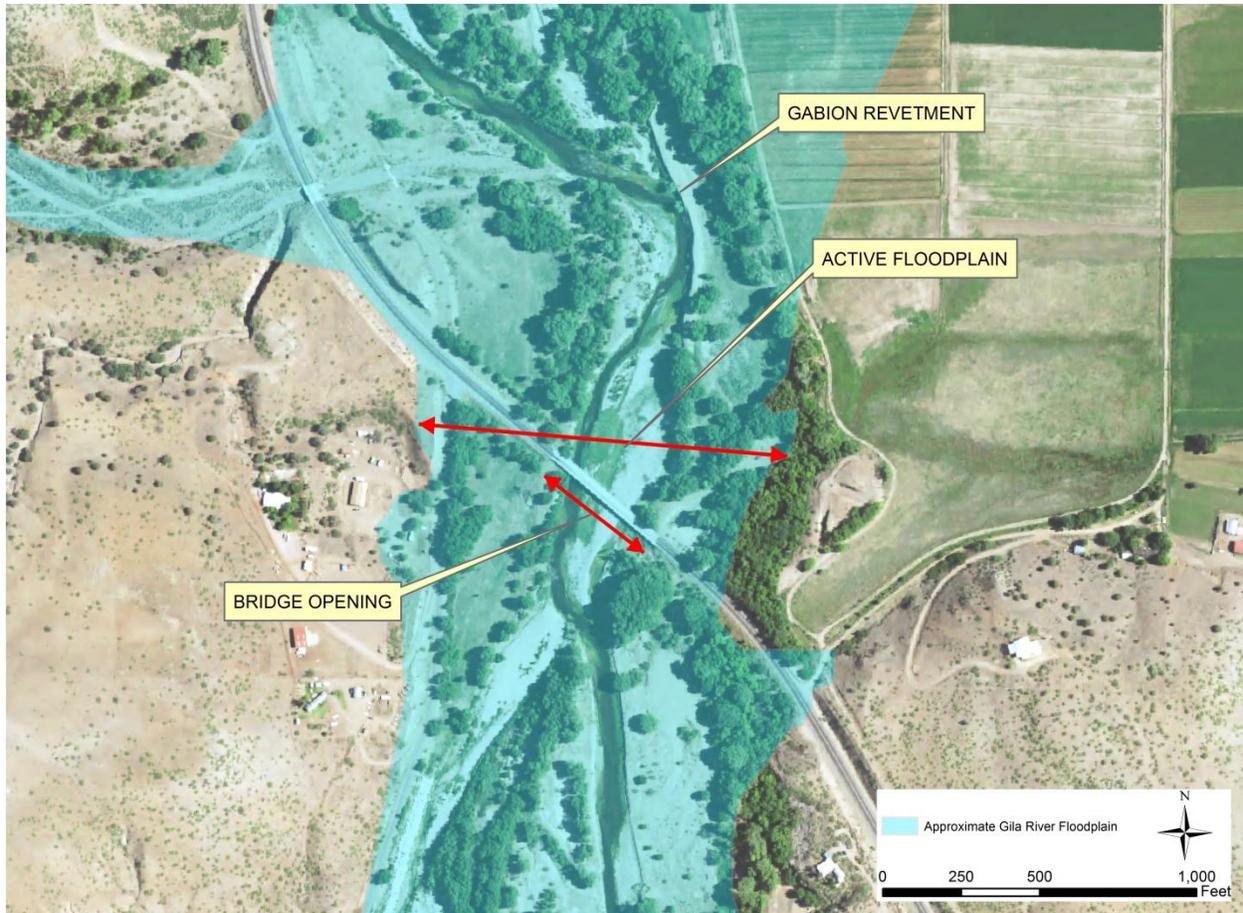
There are two bridge crossings within the study reach. The downstream crossing is on US Highway 180. The upper crossing occurs approximately 2.5 miles upstream along New Mexico State Highway 211 North (State Highway 211). Bridge abutments at both crossings appear to encroach laterally into the historic and active floodplains, contracting and accelerating overbank flows through the bridge opening. Bank stabilization activities immediately upstream of US Highway 180 crossing were observed, where failing gabion baskets are located along the river left bank. These issues are currently being studied through a research project funded through the NMDOT Research Bureau.

Figure 9 Floodplain Contraction at US 180 Bridge Crossing

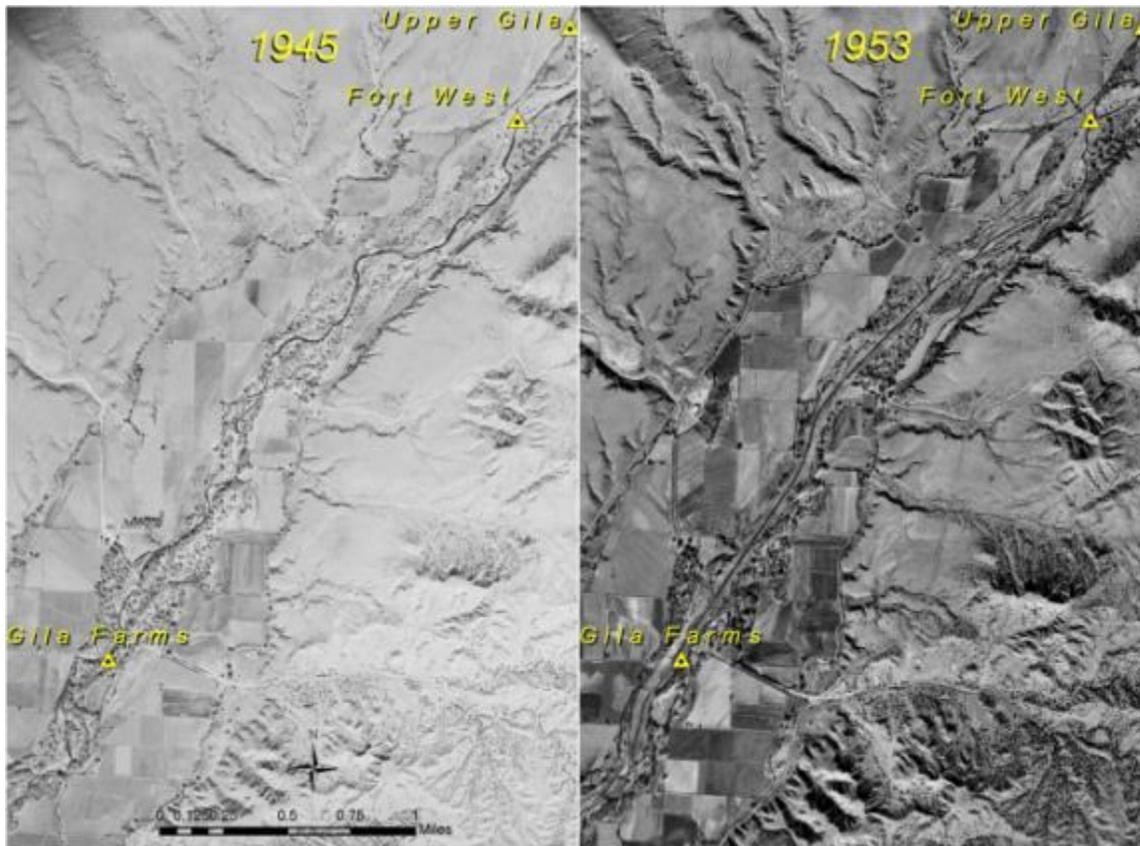
and 1953 shows the period in which channelization of the Gila River began, between the Gila Farms and Fort West diversions began (Figure 10). Aerial imagery taken between 1953 and 1964 also suggests channelization between the Gila Gage and the confluence of Mogollon Creek (Figure 11). Expansion and repair of the levee systems within the Cliff-Gila Valley was also performed following the flood of 1979, which is the second largest on record.

Figure 10 Channelization of the Reach between Gila Farms Diversion and Fort West Diversion (1945-1953)

Channel straightening steepens the river bed slope and increases stream competence to mobilize and convey sediments, resulting in greater sediment transport rates and coarser sediment loads. It can also reduce channel boundary roughness and drag through the removal of large boulders, riparian vegetation, and woody debris. Energy losses are also minimized through the reduction of the planform sinuosity, channel bedforms, or pool/riffle sequencing. Leveeing often results in greater flow depths and stream velocities coupled with reduced flow widths and overbank storage.

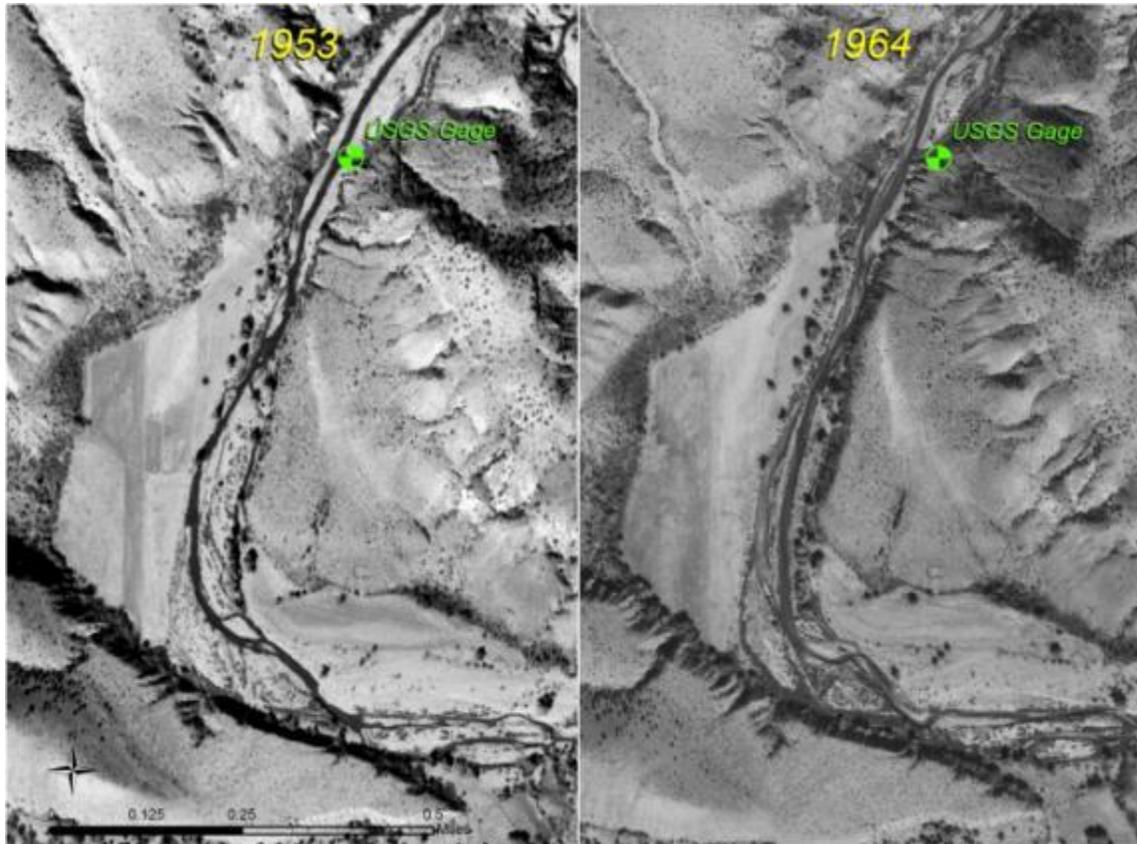
Figure 11 Channelization of the Reach between Mogollon Creek and the Gila Gage (1953-1964)

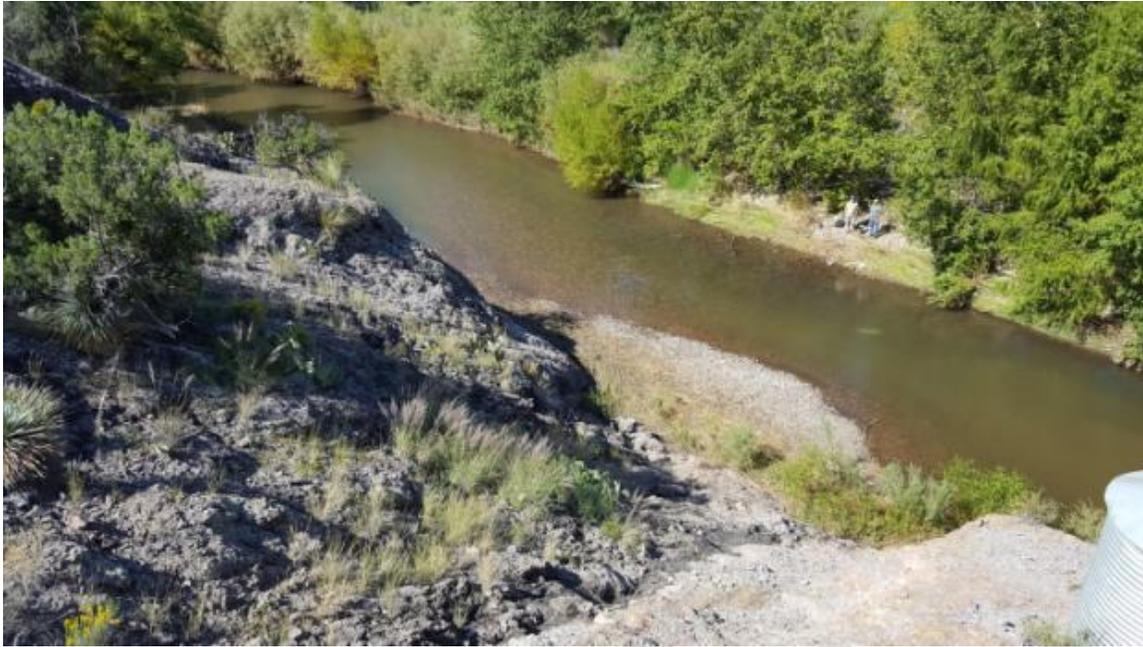
Upstream of the stream gage, at the outfall of the elevated secondary channel, evidence of ongoing erosion/sedimentation was also observed (Photo 6). Here sandy deposits were observed below the water surface and evidence of ongoing erosion was identified at the outfall of the secondary channel. A distinct elevation difference, estimated between five and seven feet, was also observed between the invert of the river channel and the outfall of the elevated secondary channel. A Wolman pebble count was conducted on the riffle downstream of the stream gage (Photo 7), near the cross section established by the USGS cable car.

Photo 7 Looking Downstream (Southwest) at the Riffle Where the Wolman Pebble Count Was Performed

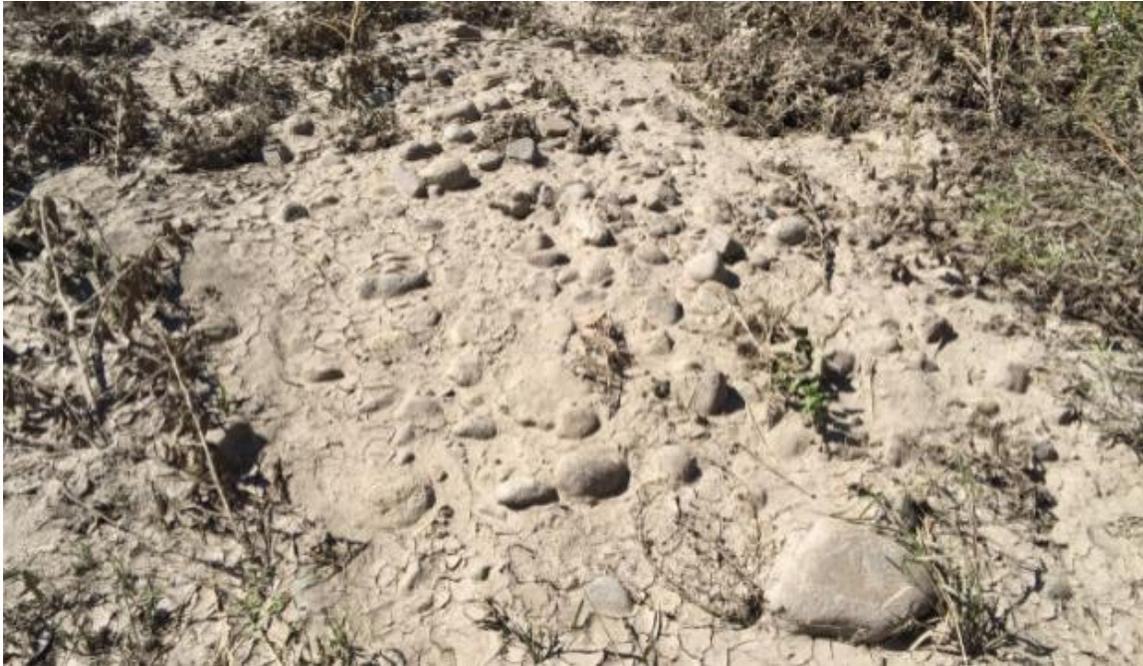
Nearing the downstream end of the investigated reach, evidence of a historic channel avulsion⁹ and headcutting was observed. Here, the active channel bifurcates, making an abrupt 45 degree angle turn to the southwest away from what appears to have been a historic alignment of the channel (Photo 10). The difference in elevation between the active channel and the historic channel is estimated at between three and four feet. The composition of the historic channel bed appeared similar to that observed at the location of the Wolman Pebble Count at the Gila Gage (Photo 11). It could also be seen that a recent high flow event accessed the historic channel, as evidenced by recently deposited sediments and ponding (Photo 12).

Photo 11 Looking at the Composition of the Dry Bed of the Historic Channel
