New Model Canal Improvement Project Assessment of Potential Environmental Impacts

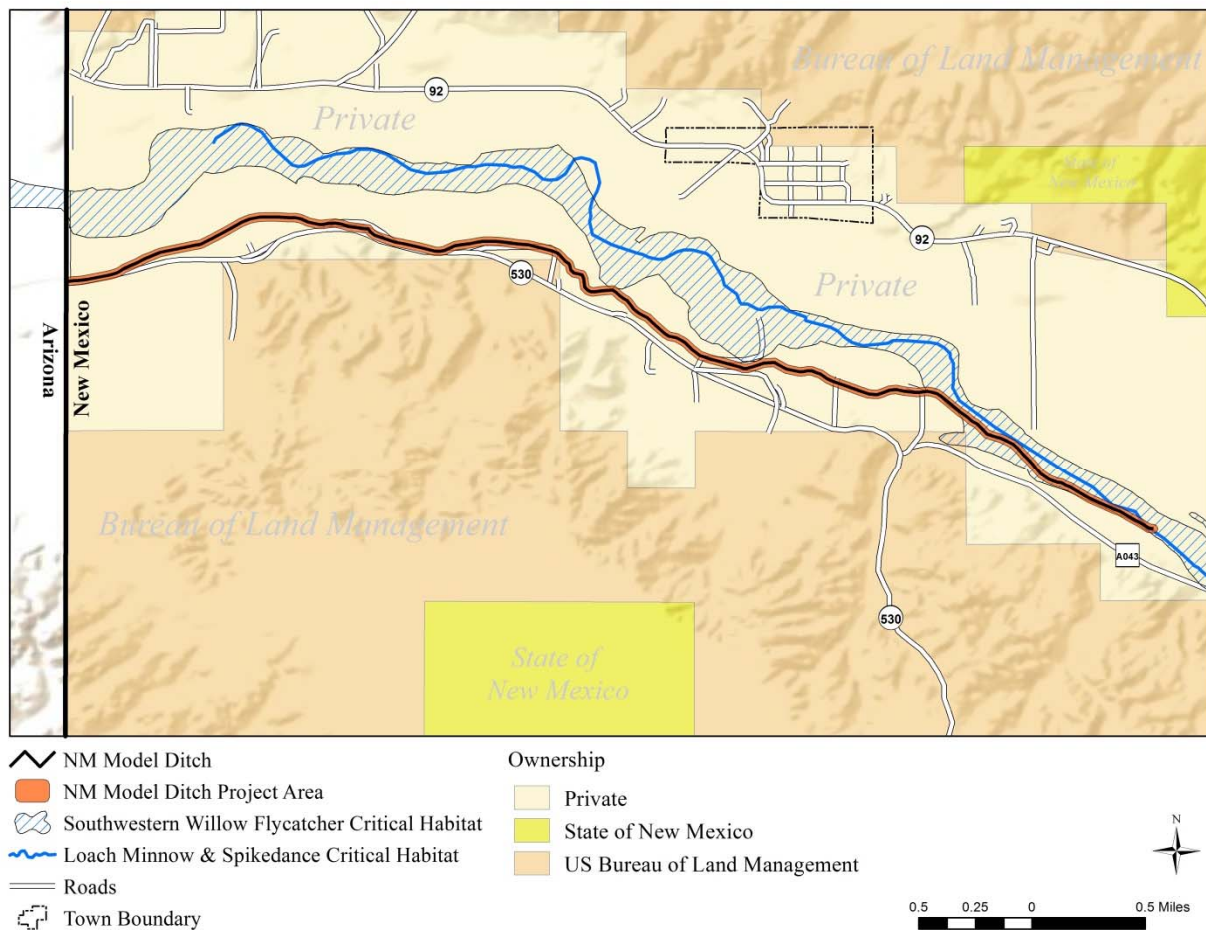
Figure 1. New Model Improvement Project Area.

Environmental impacts were assumed to primarily result from operations activities associated with improving/rehabilitating the system. For analysis, the PA project area was defined as the ditch/piping infrastructure and a 100-ft buffer area, which is considered conservative, on either side of the ditch/pipe. The buffer area was chosen as an approximation of where project activities (e.g., pipe removal/installation, equipment/vehicle travel, materials staging) would likely take place and where impacts would have the highest likelihood of occurring. The PA project area is shown on Figure 1.

Five species, the Loach minnow (*Tiaroga cobitis*), Southwestern Willow flycatcher (*Empidonax traillii extimus*), Spikedace (*Meda fulgida*), Narrow-headed garter snake (*Thamnophis rufipunctatus*), and the Northern Mexican garter snake (*Thamnophis eques megalops*) are likely to be found within the project area (USFWS 2014). Their status and habitat requirements are shown in Table 1. Both the Loach minnow and the Southwestern Willow flycatcher have designated critical habitats adjacent to the PA project area, and within the project area for the flycatcher, along a small section of the project at its eastern extent, as shown on Figure 1.
