Figure 6.25 Map showing water-level elevation contours, 1995-2000, Mesilla Basin, Dona Ana County, New Mexico.

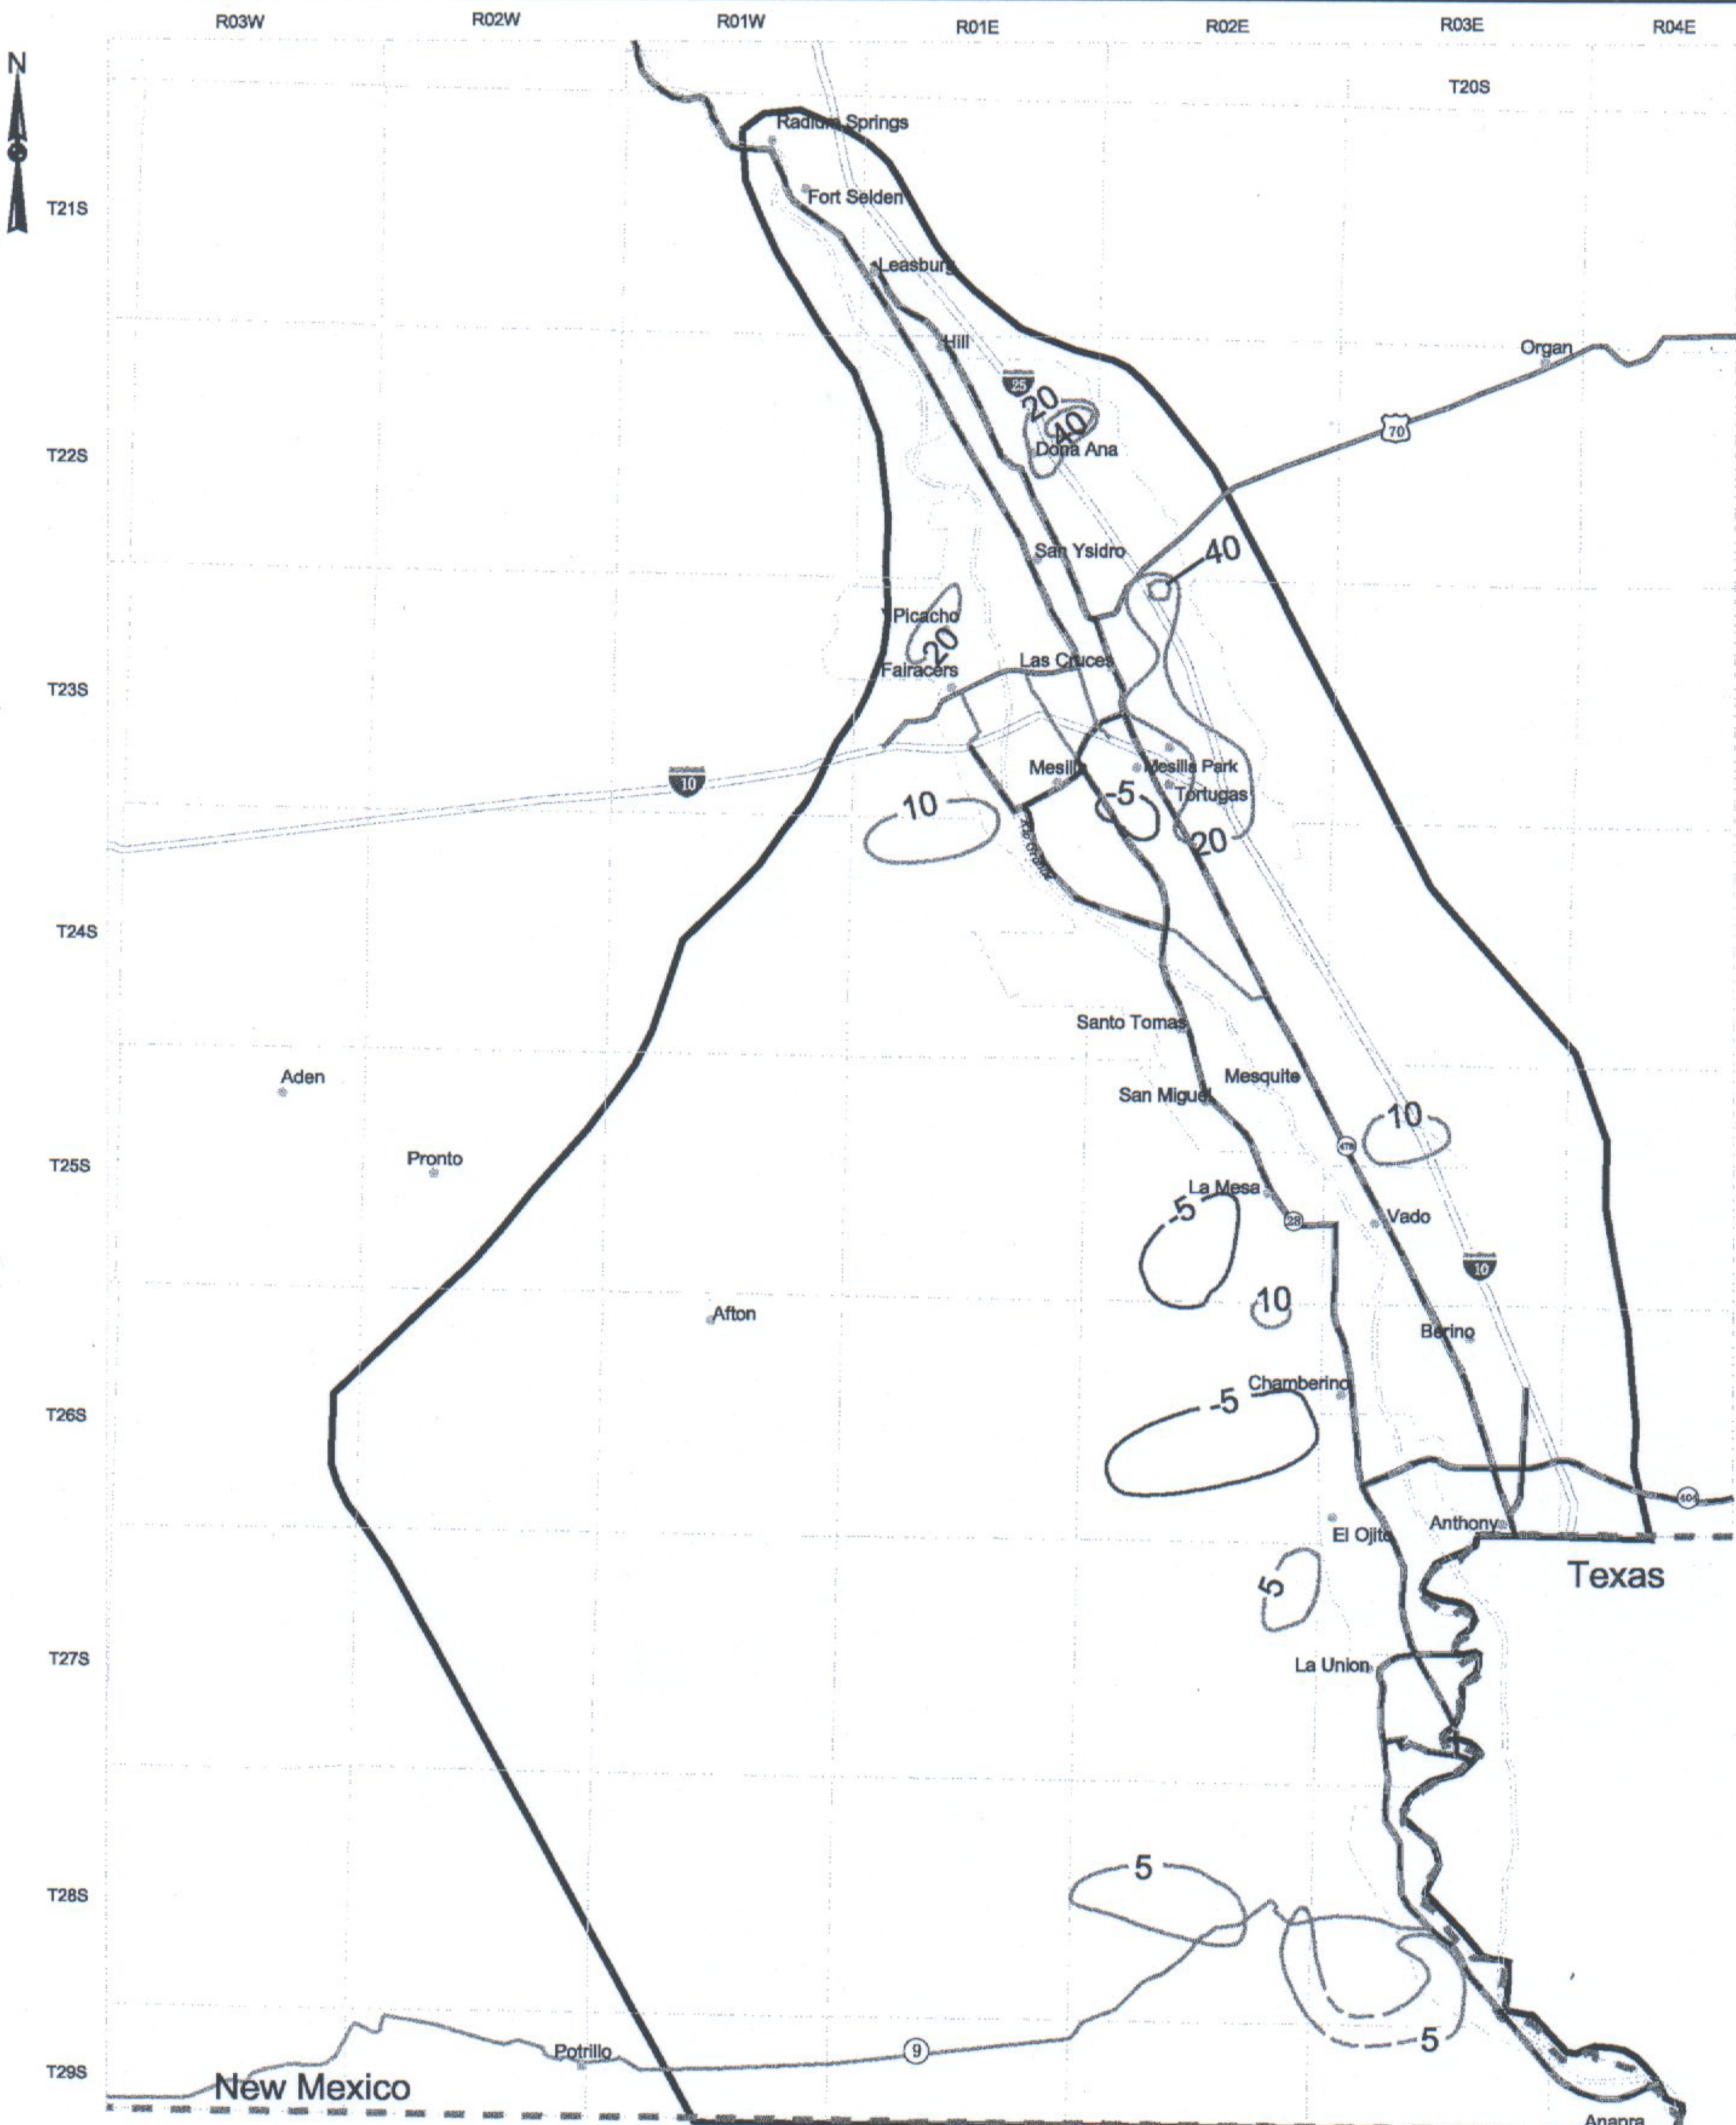
Figure 6.26 Map showing water-level changes from 1978 to 2000, Mesilla Basin, Dona Ana County, New Mexico.

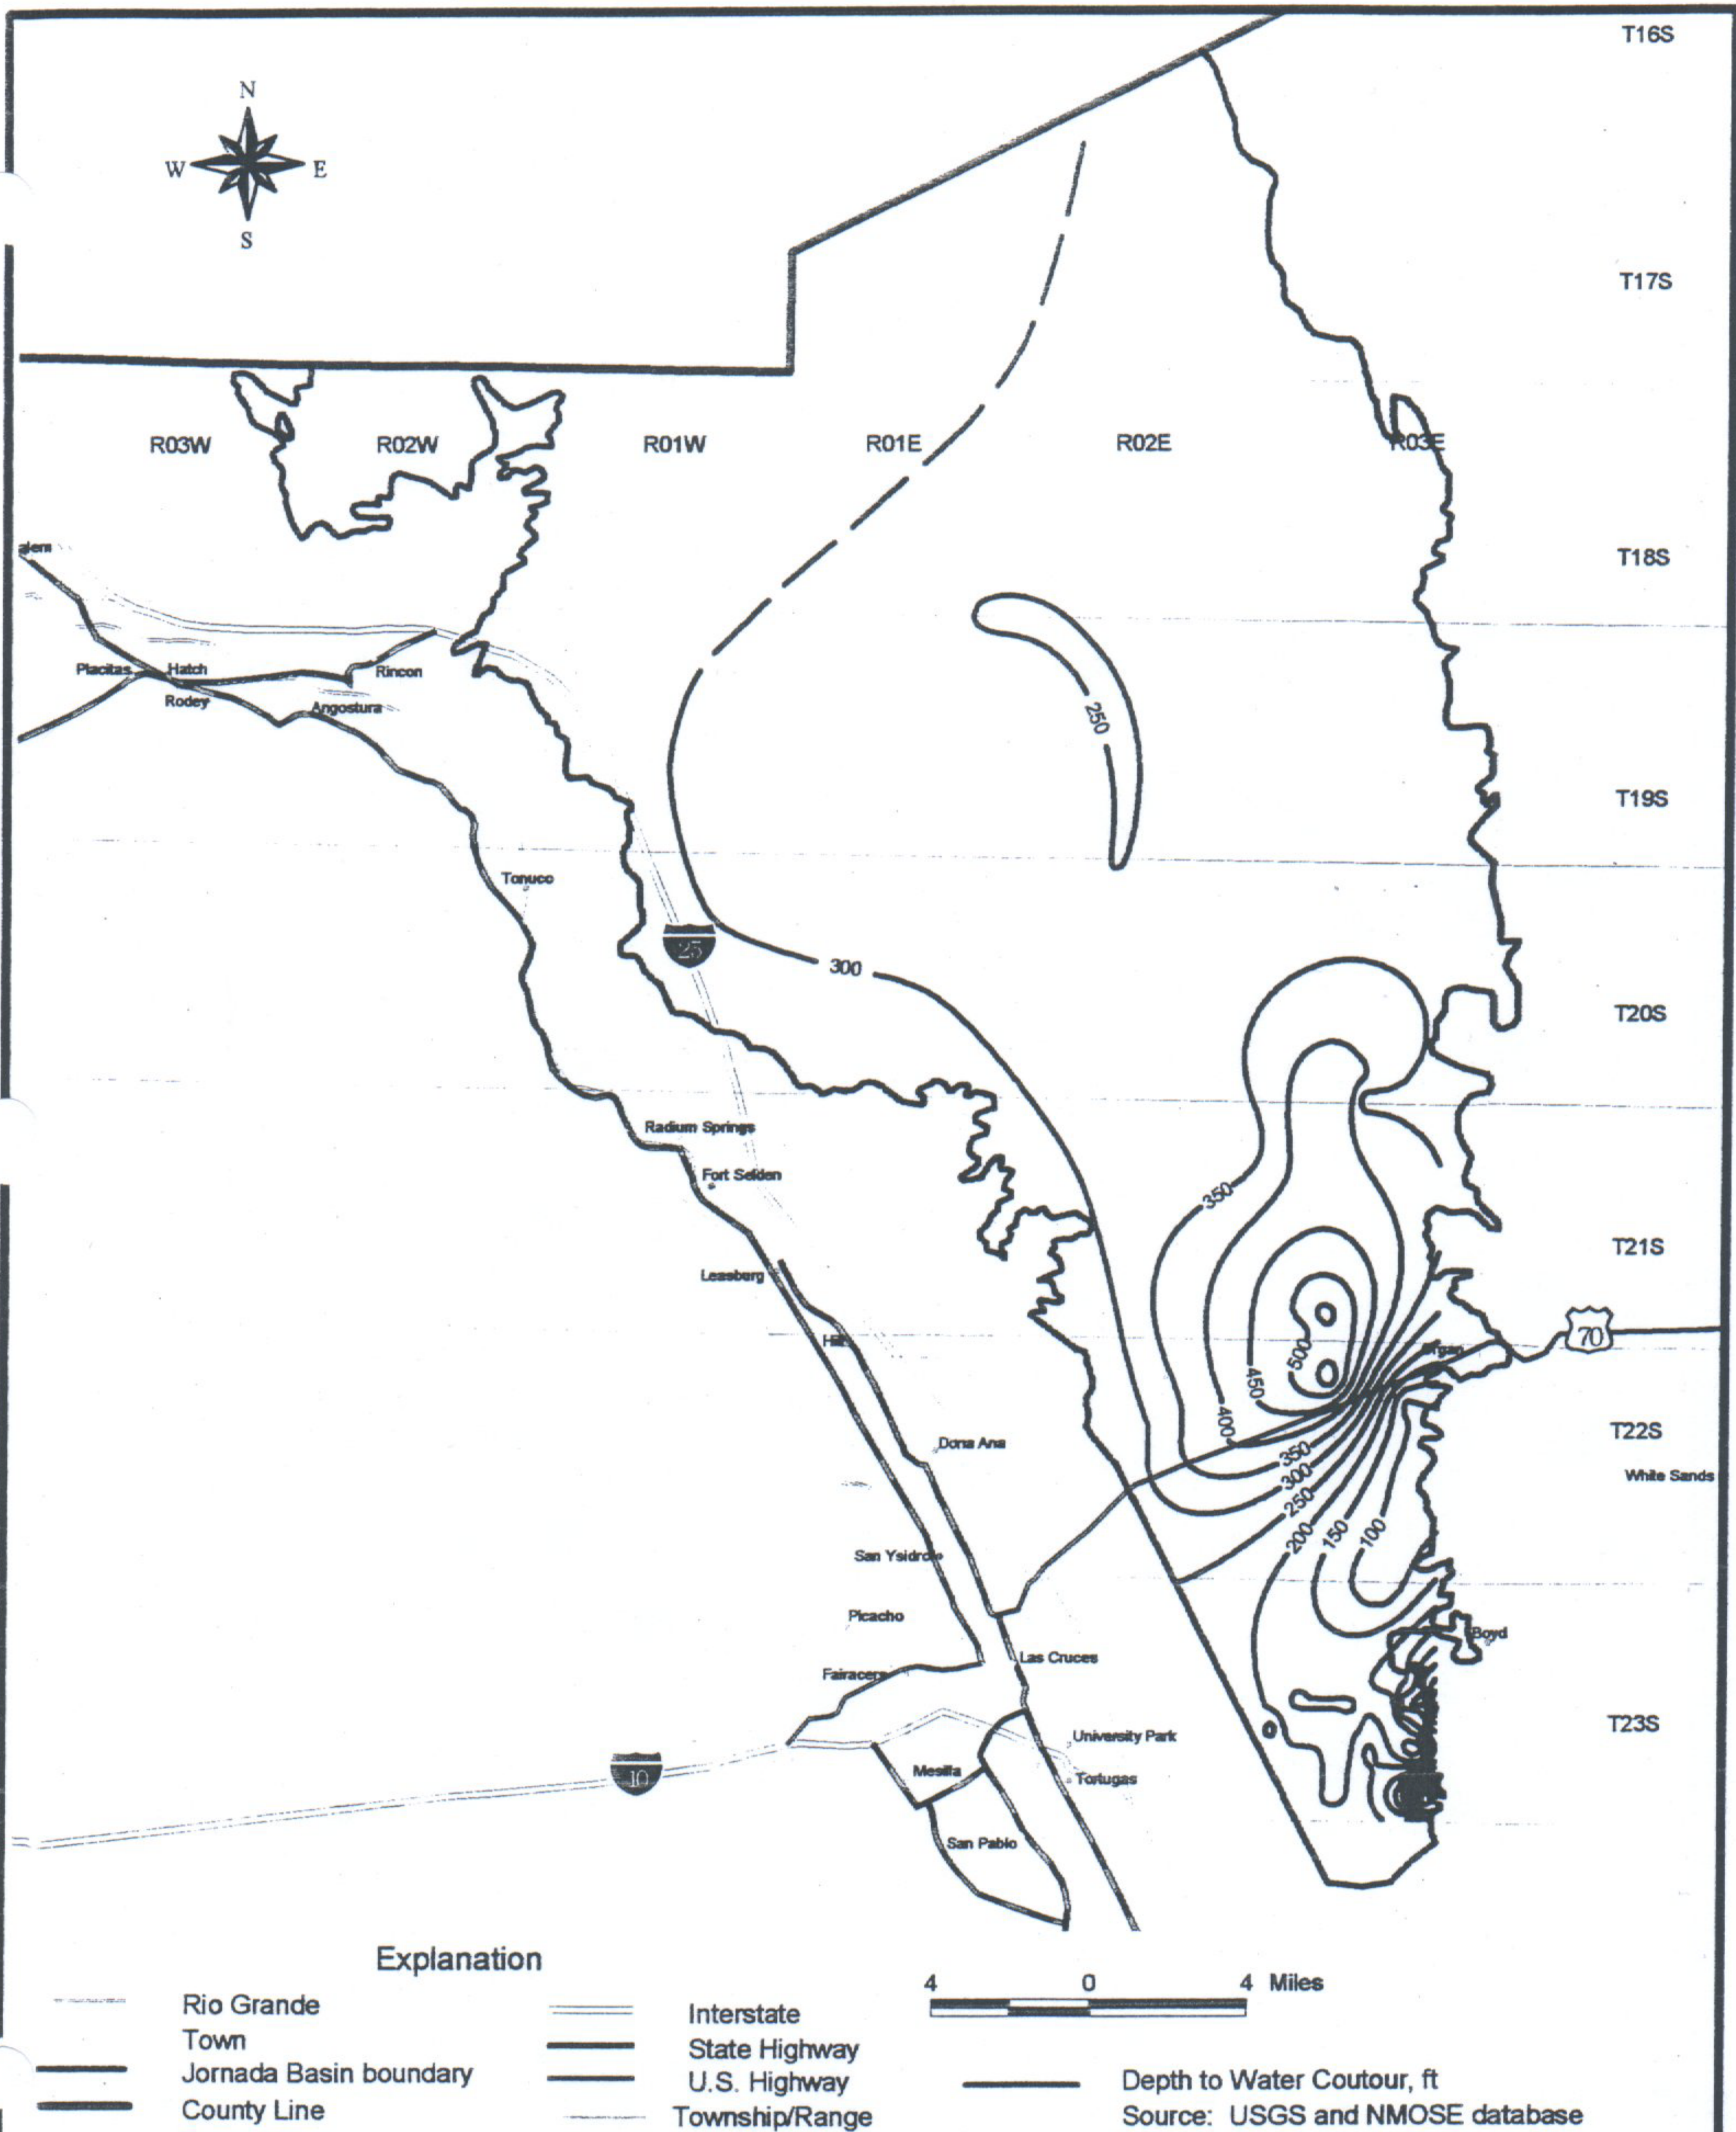
Figure 6.27 Map showing depth to water contours, 1995-2000, Jornada Basin, Dona Ana County, New Mexico.

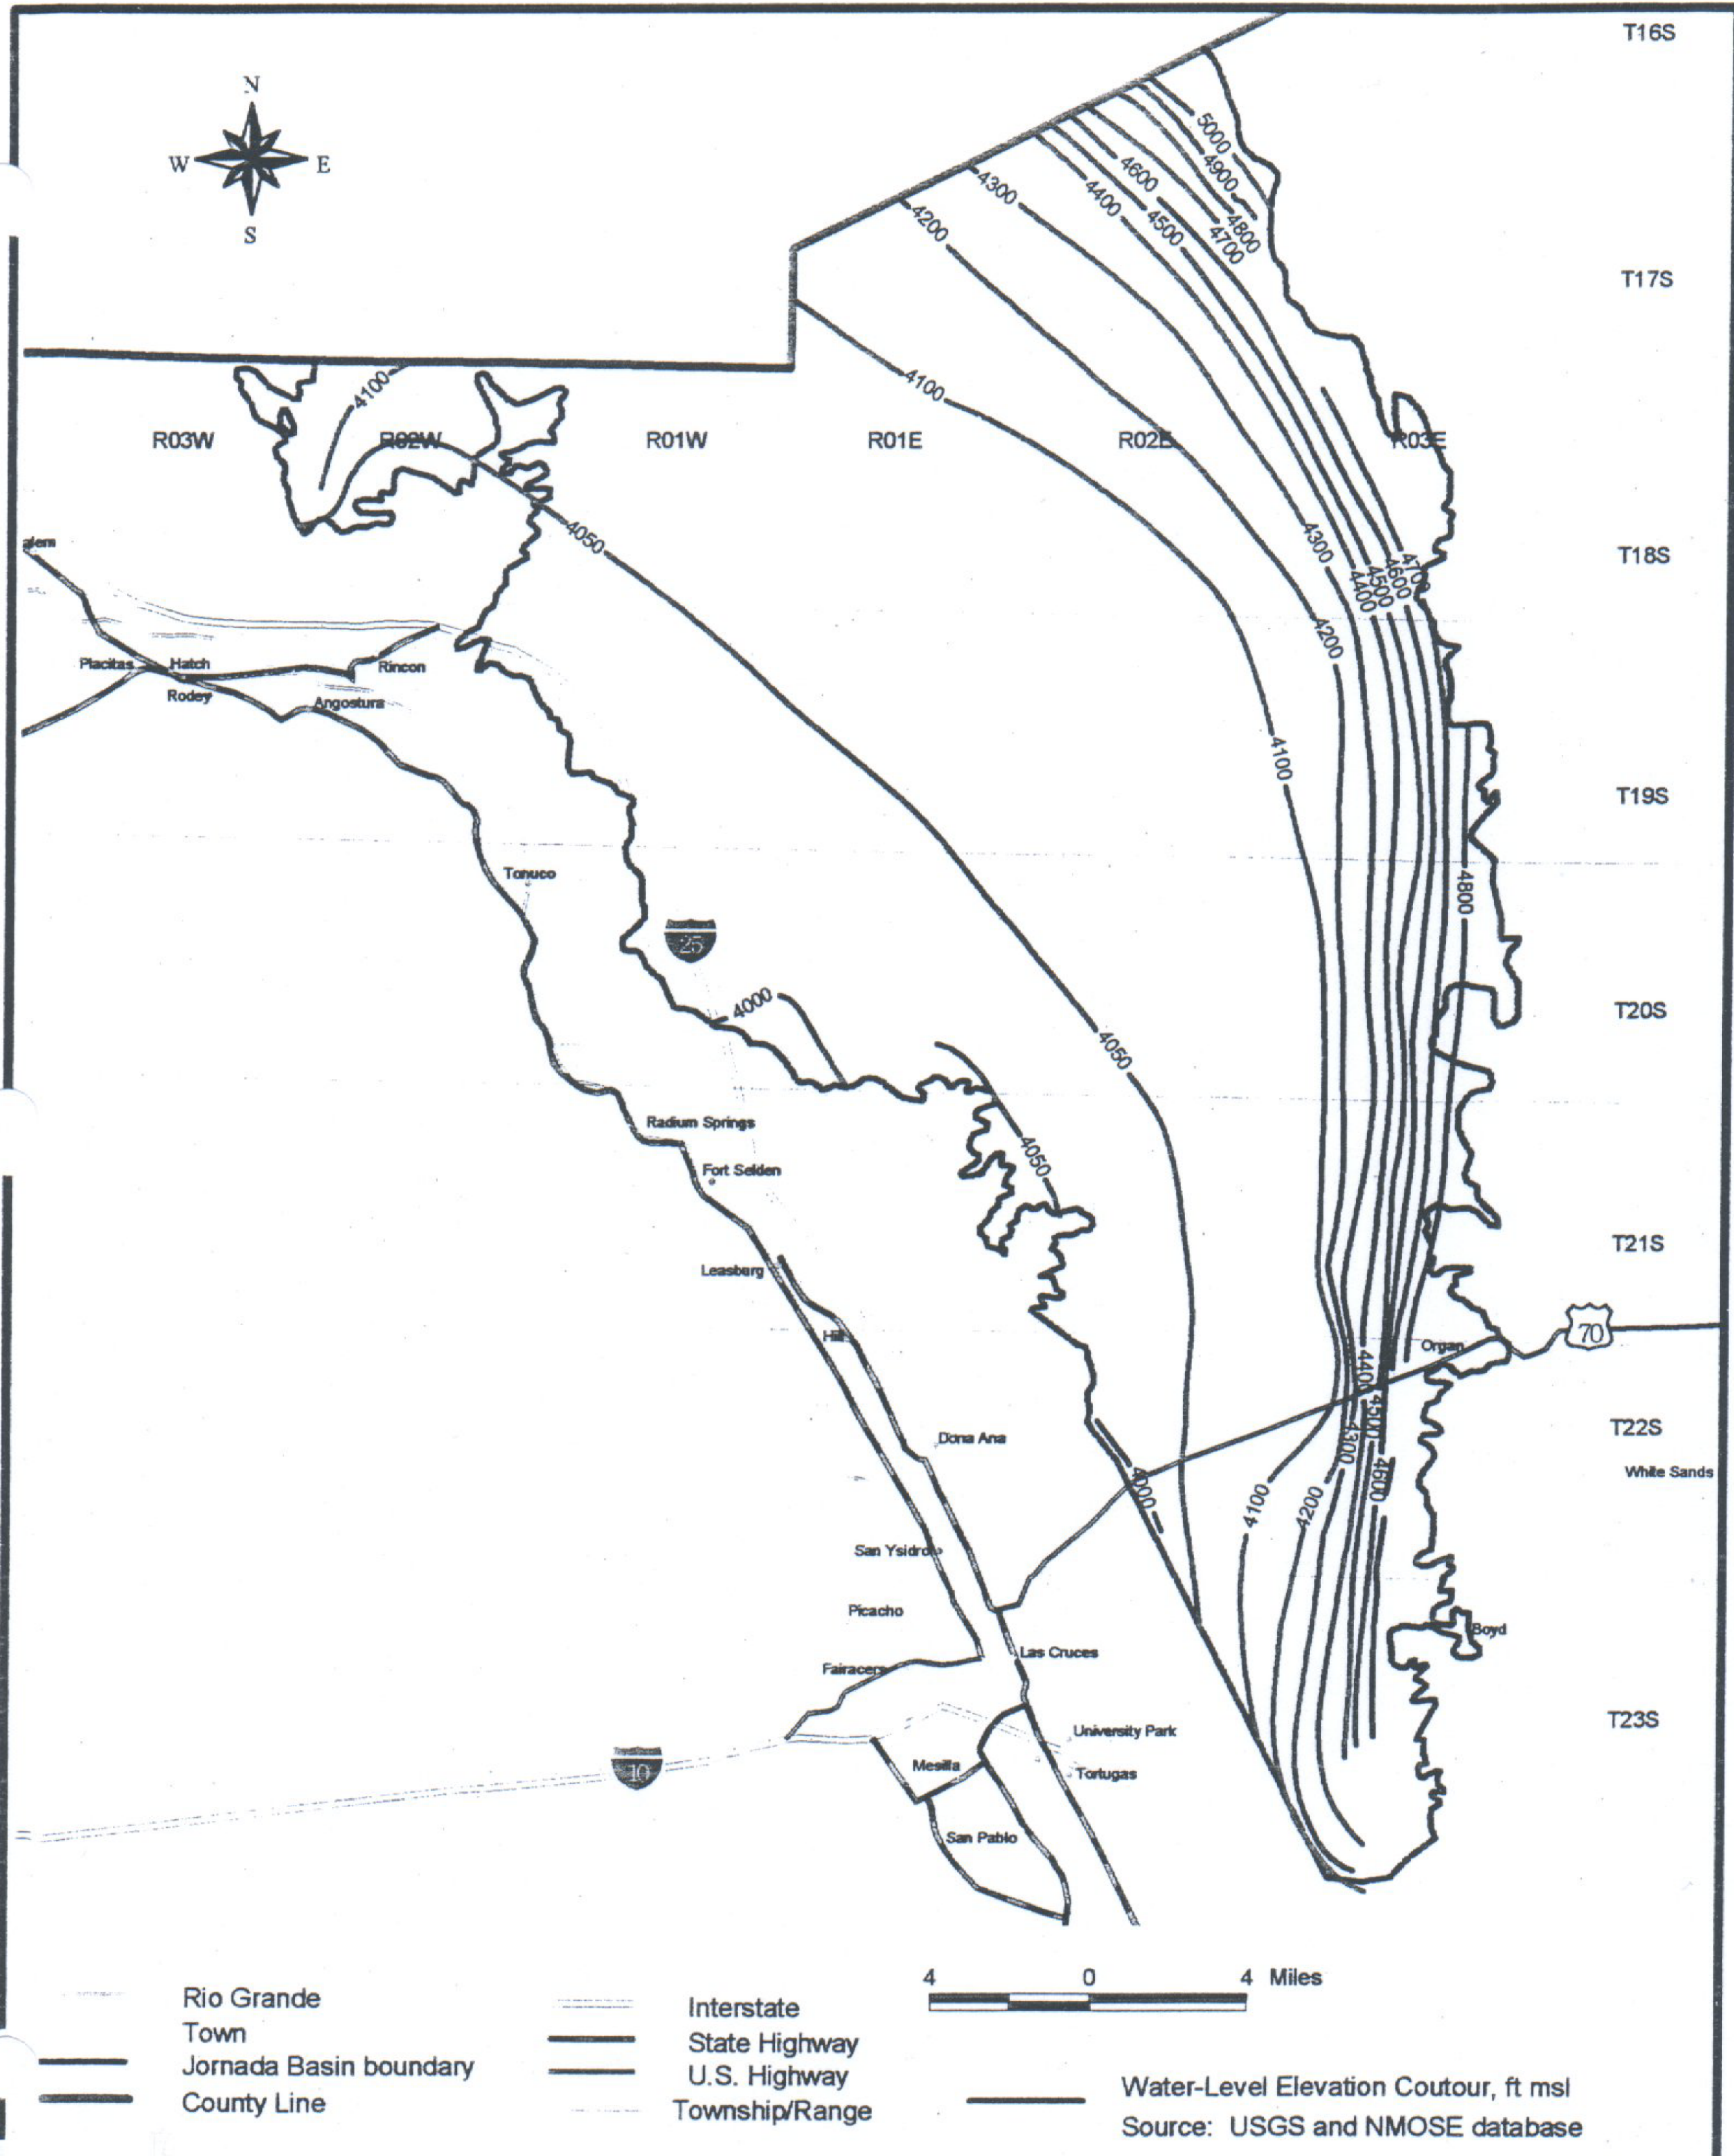
Figure 6.28 Map showing water-level elevation contours, pre-1970 development, Jornada Basin, Dona Ana County, New Mexico.

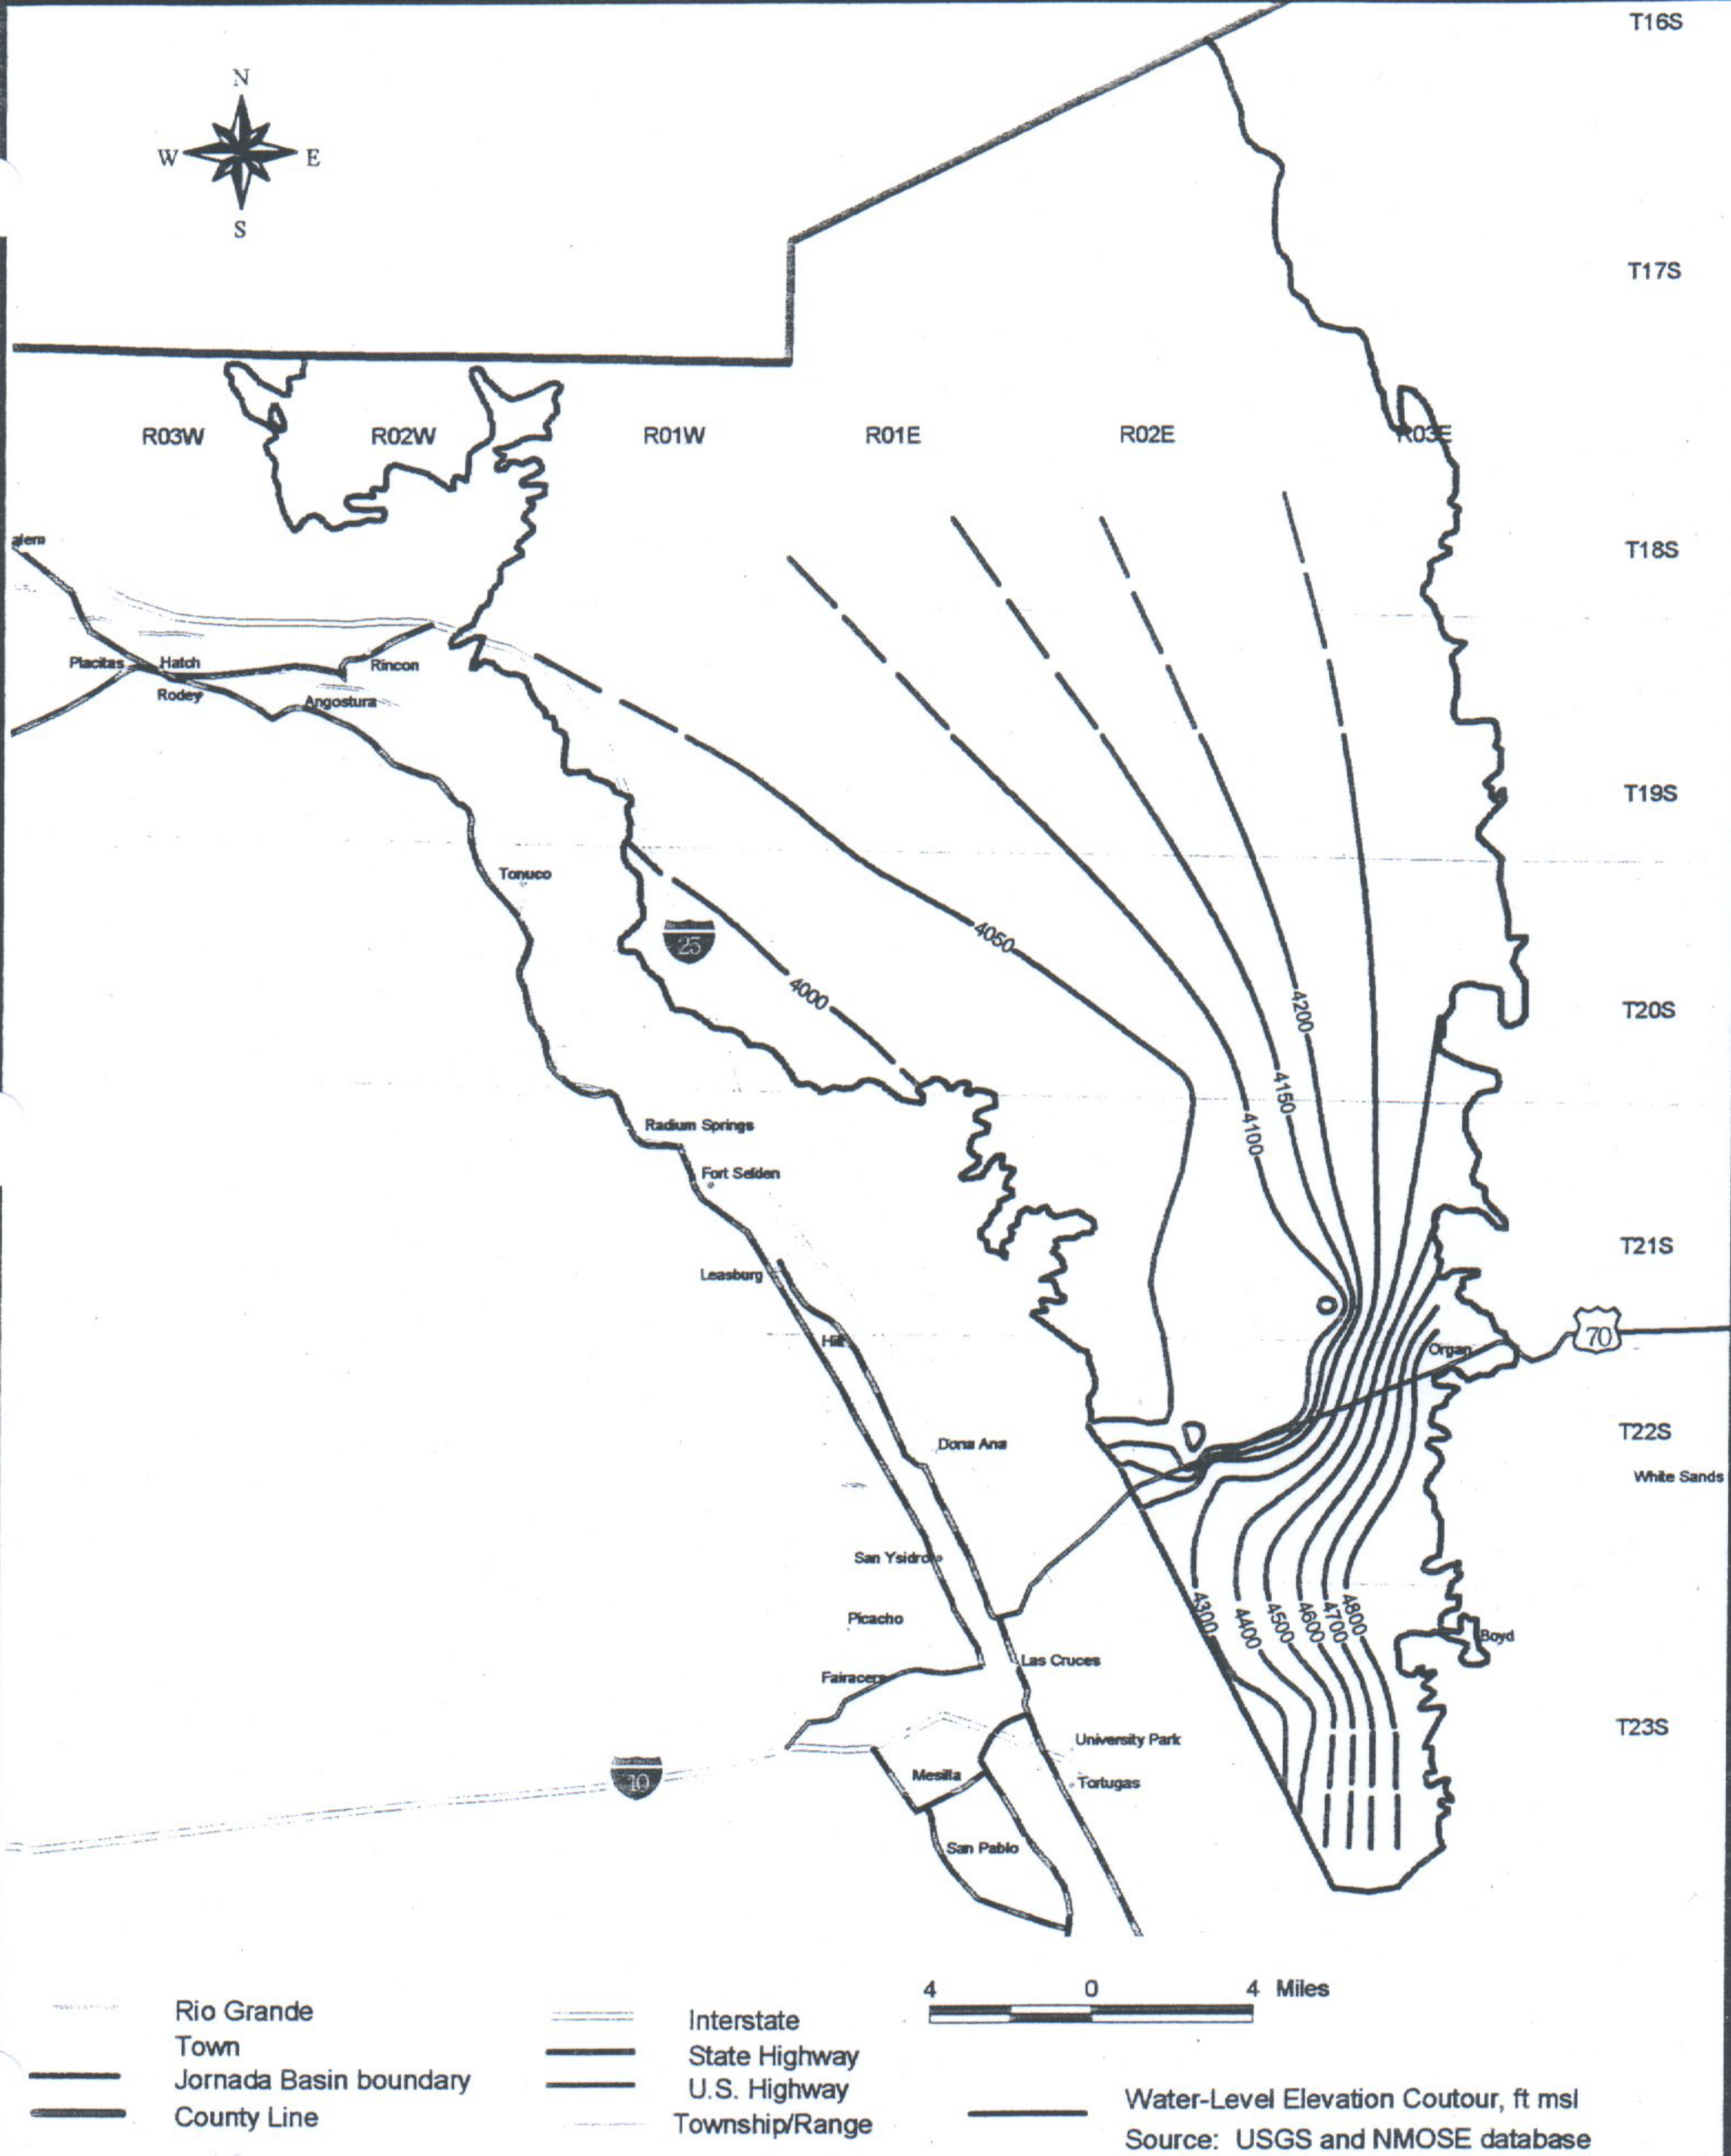
Figure 6.29 Map showing water-level elevation contours, 1978-1983, Jornada Basin, Dona Ana County, New Mexico.

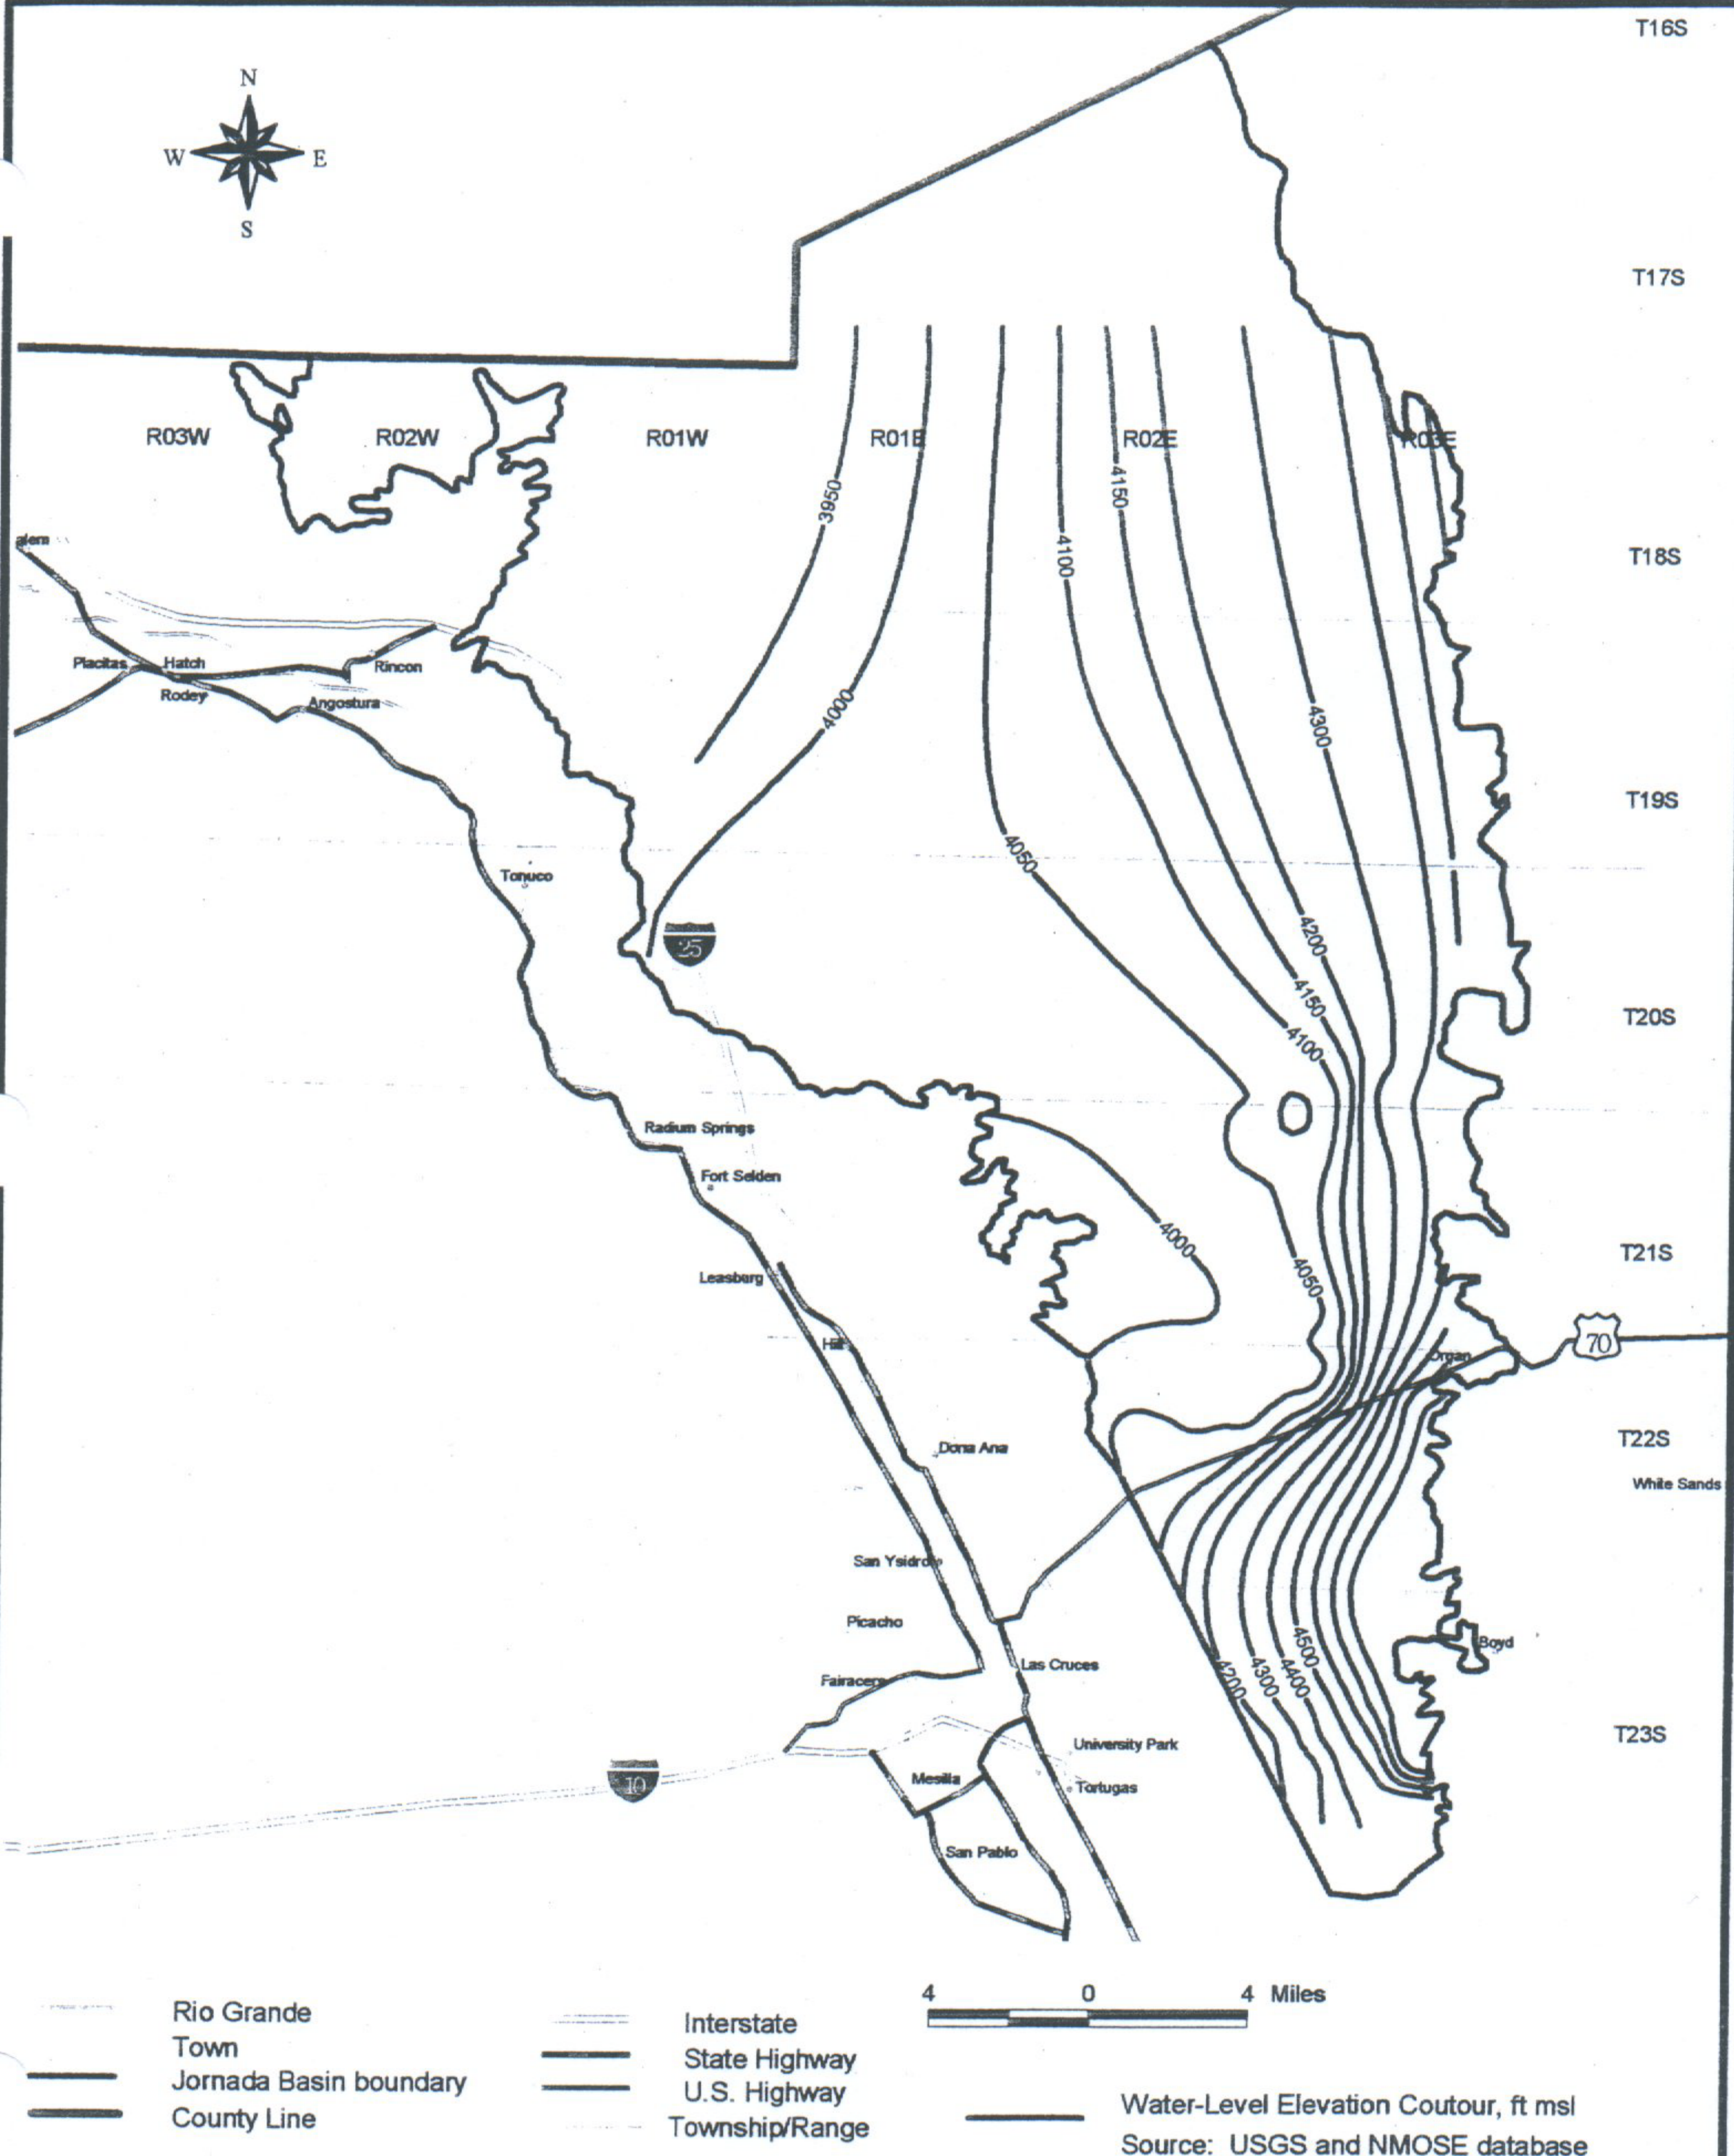
Figure 6.30 Map showing water-level elevation contours, 1995-2000, Jornada Basin, Dona Ana County, New Mexico.
