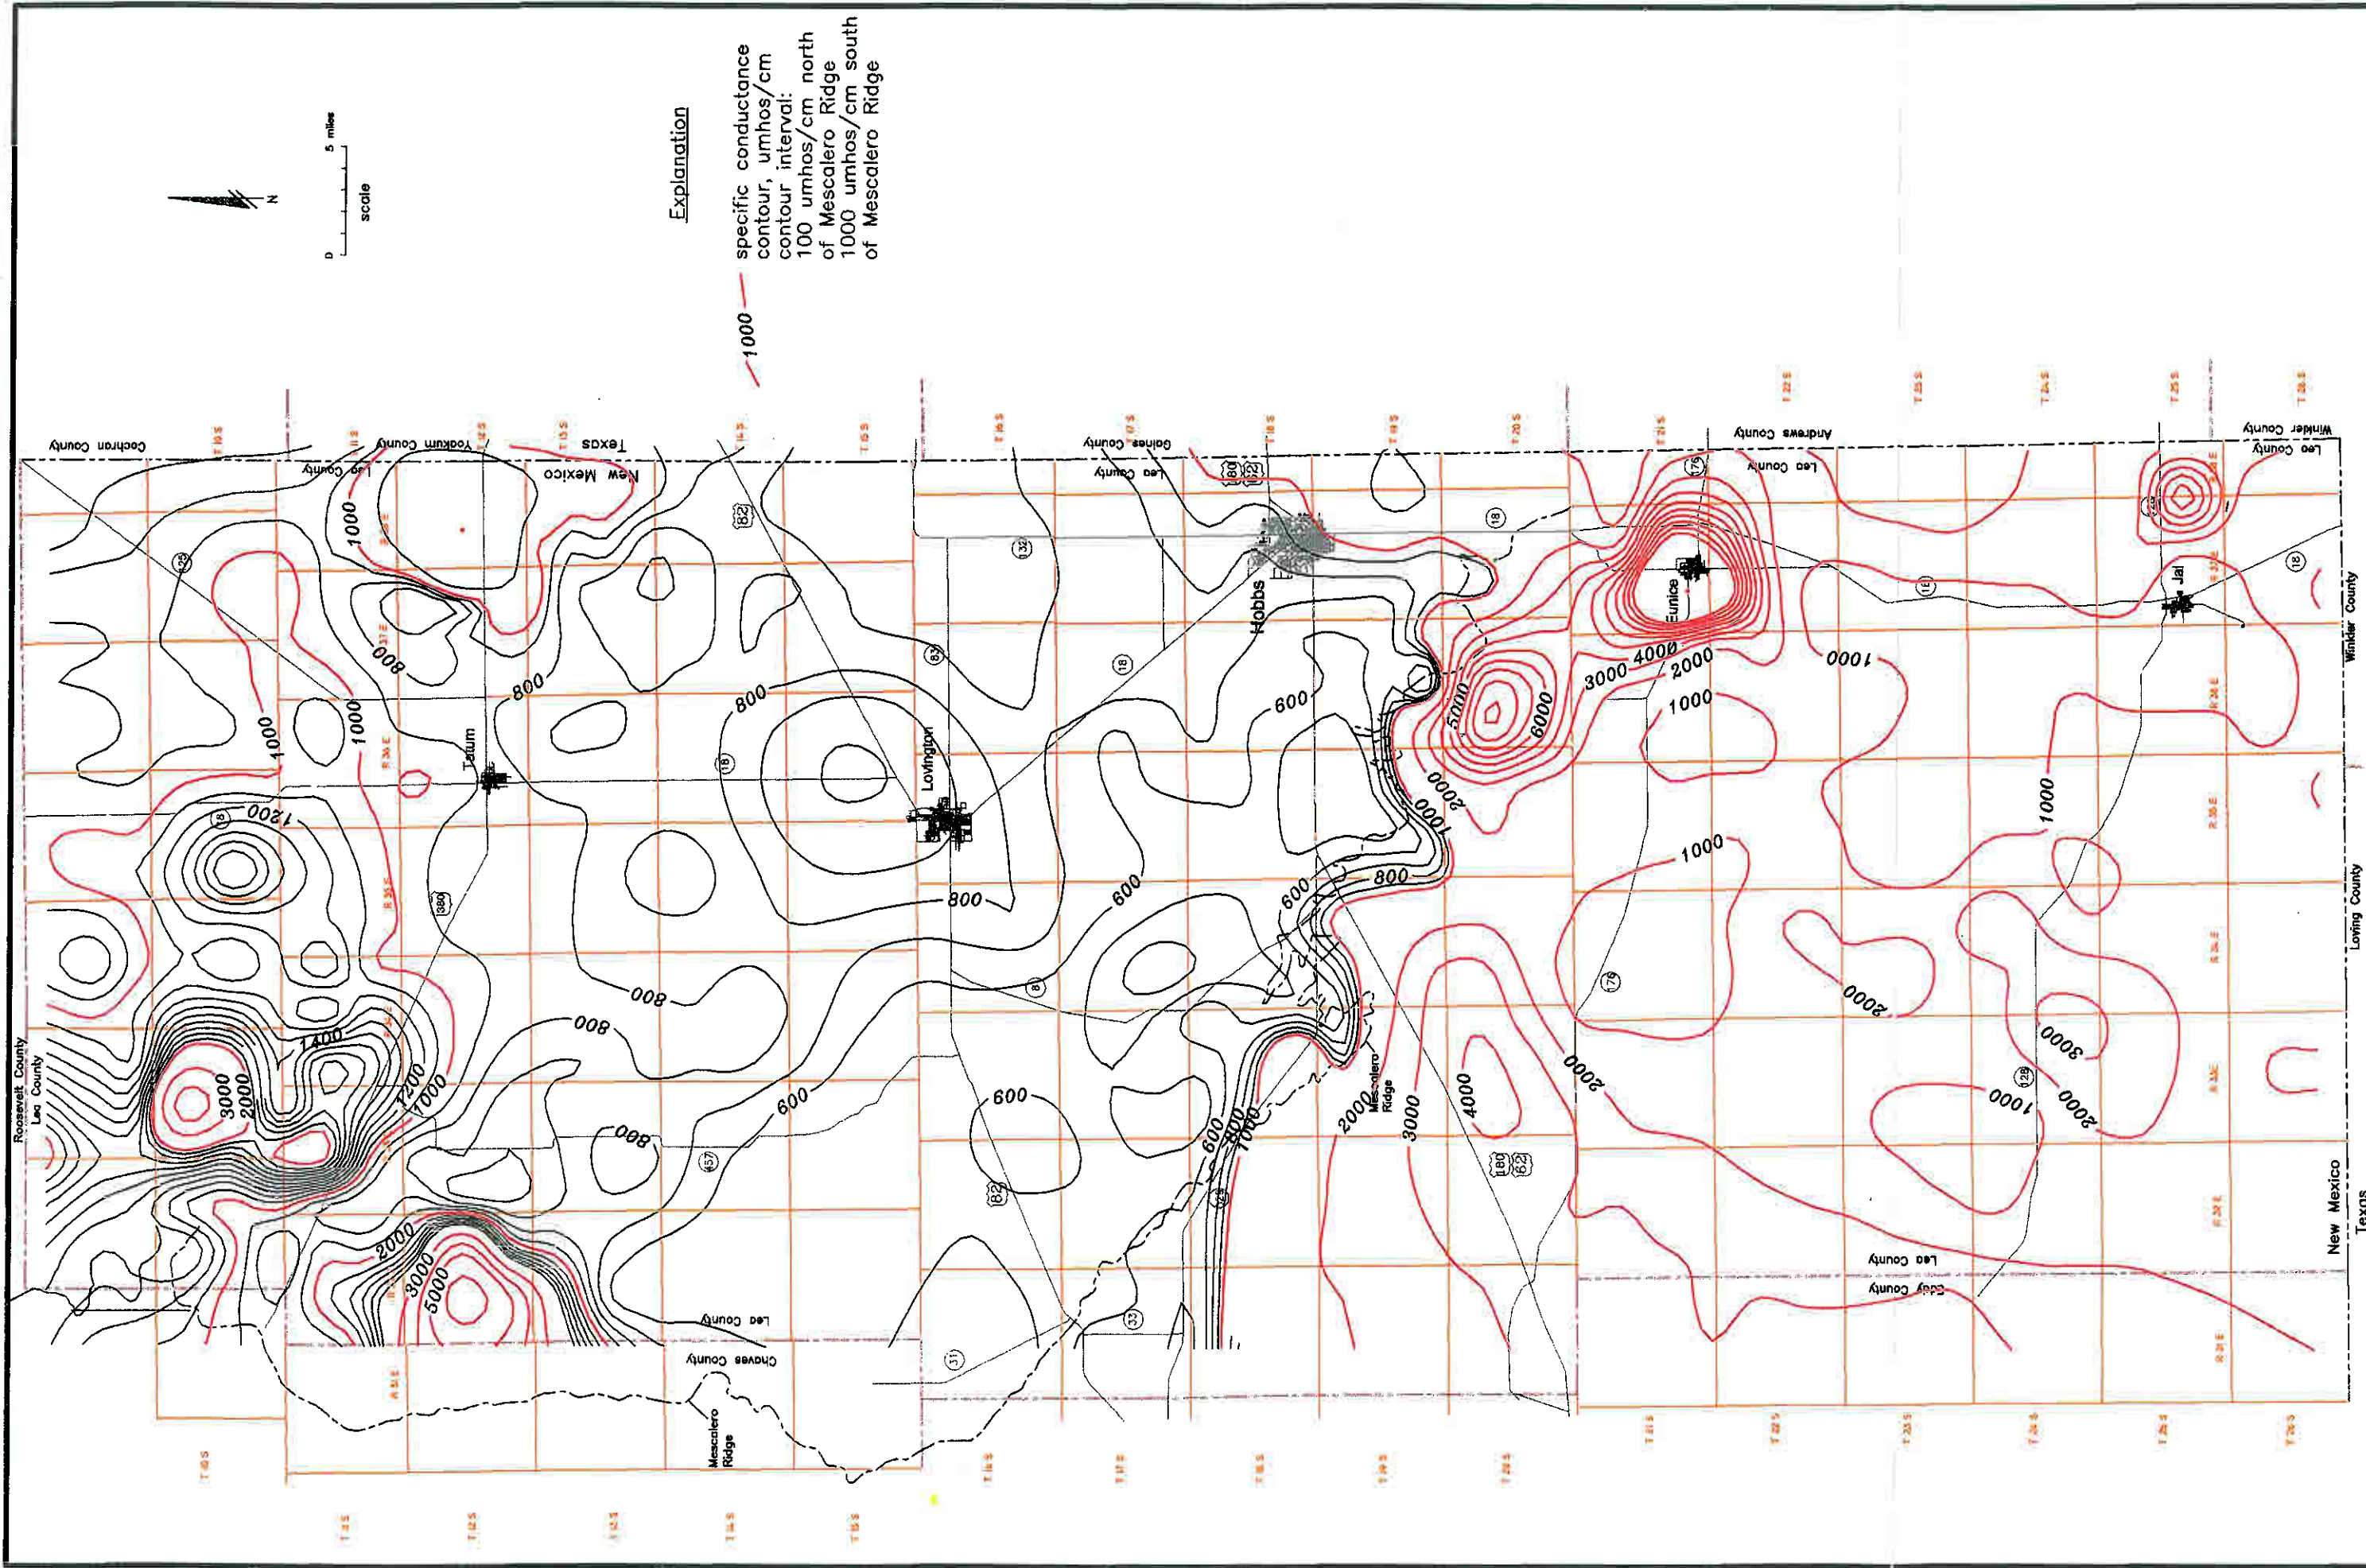
Figure 30. Map showing specific conductance, mid 1980s, Lea County, New Mexico.

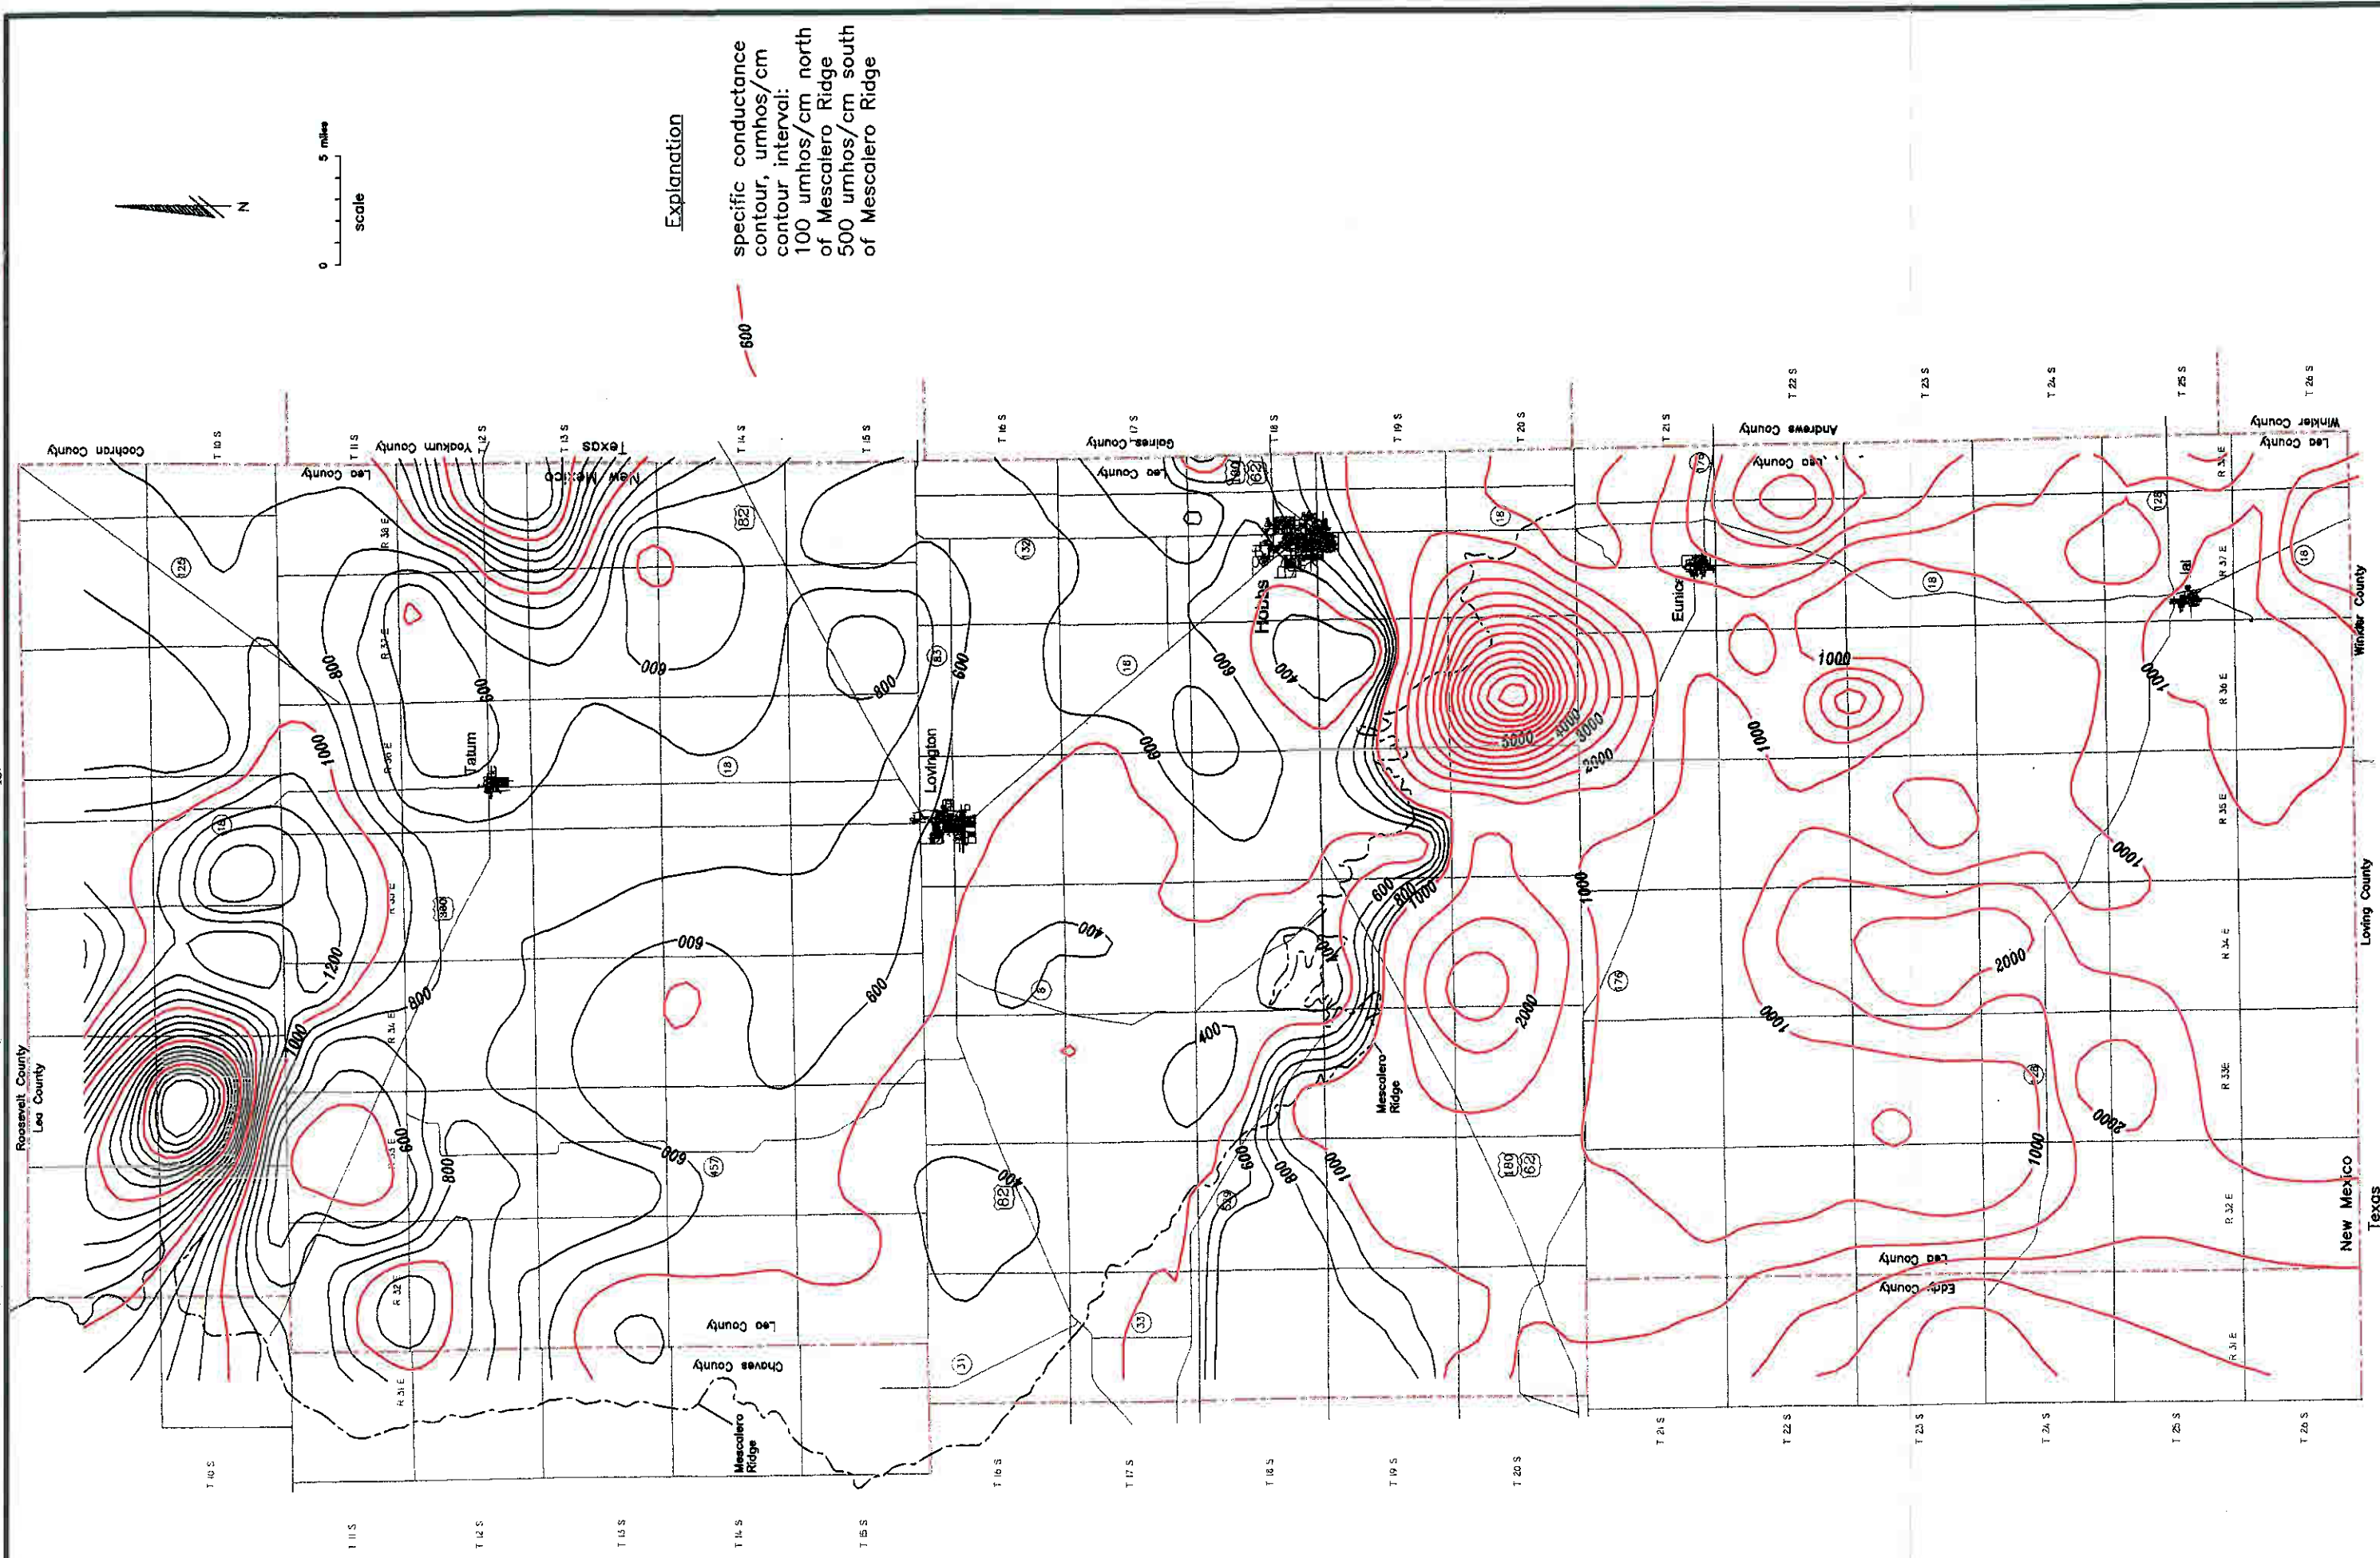
Figure 31. Map showing specific conductance, 1995–1998, Lea County, New Mexico.

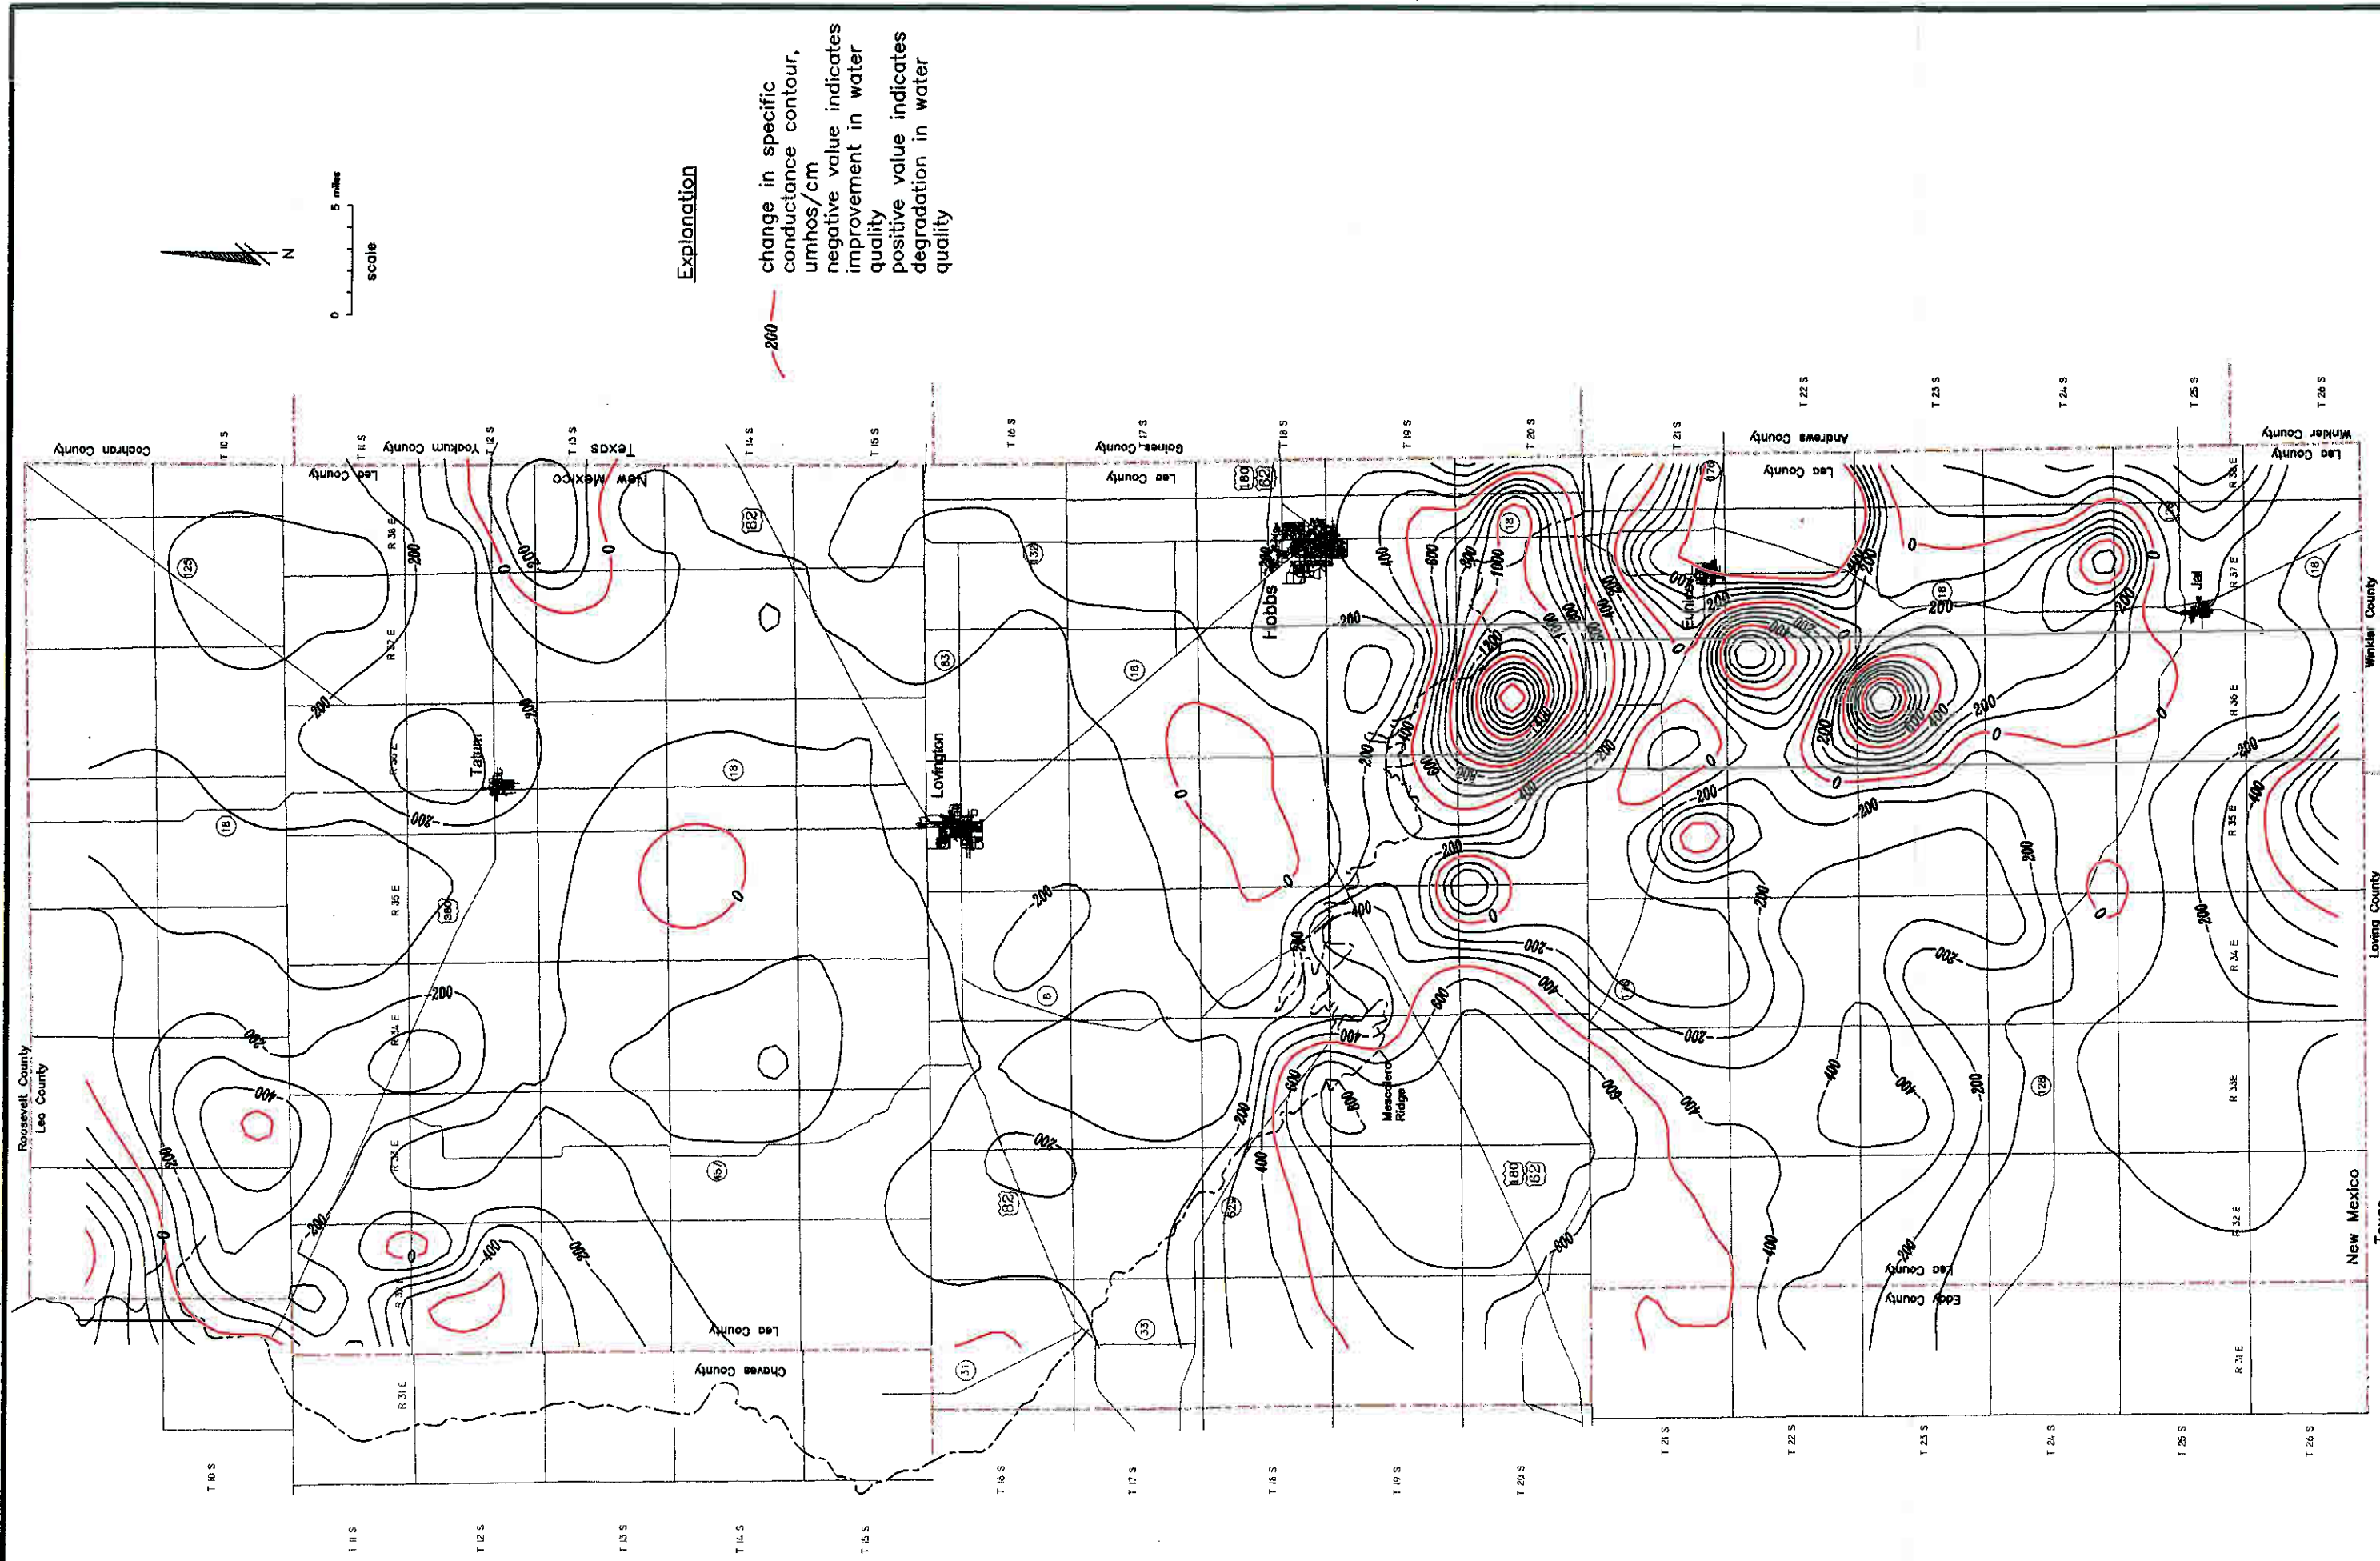
Figure 32. Map showing changes in specific conductance, mid 1980s to 1998, Lea County, New Mexico.
